BS5837:2012 Tree Survey
 Land west of Leconfield Road
 Loughborough
 Leicestershire
 NGR SK50951 17549

Report prepared by: C Barker	Date Issued: 17 August 2021
		Report Version: Final v3
	Reviewed by: KLB	C B E Consulting Highbank, 5 Grantham Road, Navenby Lincoln. LN5 0JJ. Telephone (01522) 810086. www.cbeconsulting.co.uk
	Report ref: P2164 /0521 /02

BS5837 Tree Survey, Land west of Leconfield Road

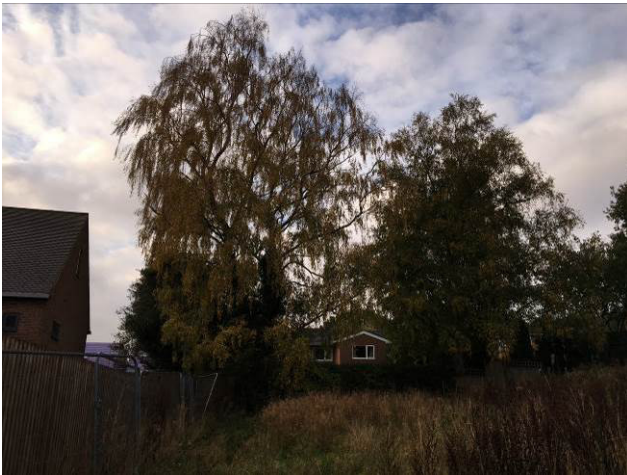
T1 – T2

Trees T1 – T3 comprise two Birch trees of Category B and one Oak of Category A positioned within a garden approximately 1m to the south of the field boundary outside of the site area. These trees provided canopy cover and partial screening to the garden supported by a trimmed Hawthorn hedge. These are trees of good quality and the canopies extend across the field boundary at height. It is unlikely any facilitation pruning will be required but the RPA's will need to be protected.

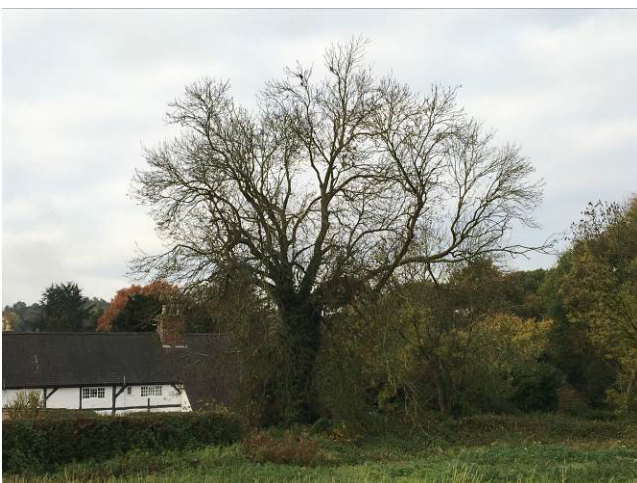
Trees T4 and T5 are situated close to the south-western corner of the site within the survey area and site boundary. Ash T4 is a large mature tree of significant stature placed within Category B. The RPA and canopy of this tree extend across the field boundary and will require protection measures. Willow T5 is a small tree of little landscape significance that present no constrain to development and it is placed within Category C.

T4	Ash <i>Fraxinus excelsior</i>	18	765	8m on north side	5	M	20	F	Single trunk within an adjacent garden supporting a very broad irregular spreading canopy. Negligible roost potential. No structural faults visible from ground level	Retained. Protect the canopy and RPA on the north side with fencing. No canopy work required.	B2	9.1

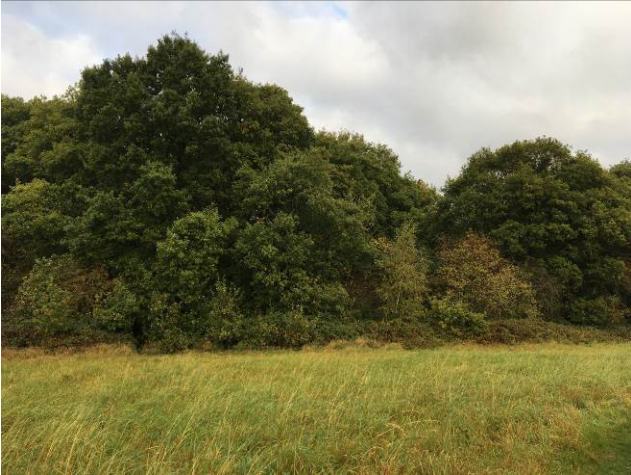
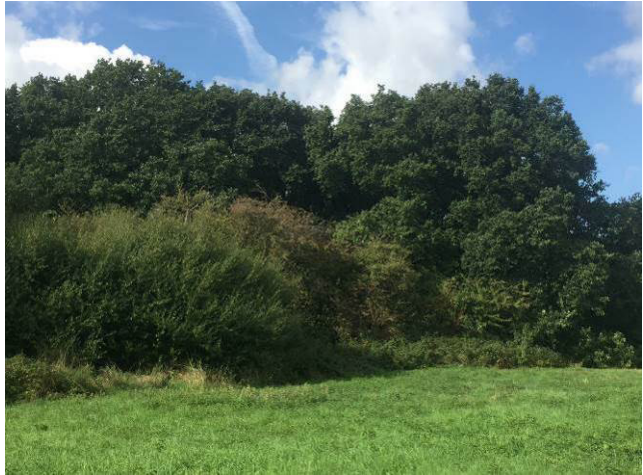
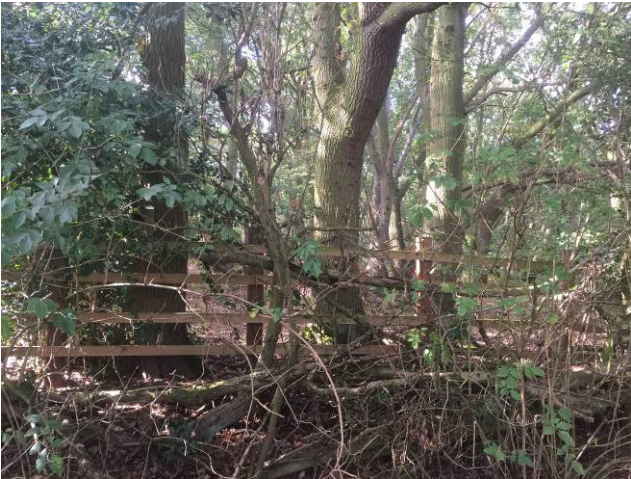
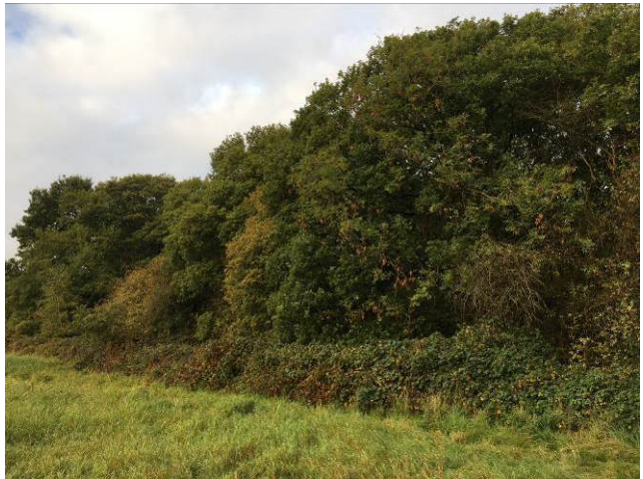
Trees T6 and Group G7 comprise mature Oak along the boundary of Burleigh Wood outside of the site area. These are trees of significant stature with many other mature trees further to the west forming a large woodland area. These trees are highly visible from within the site and adjacent residential houses and are placed within Category A. The crown extents and RPA extend across the site boundary and protection measures will be required.

T7	5 x Oak <i>Quercus petraea</i>	16-19	<450	7m on east side	0	M	40	G	Group of Oak within the edge of Burleigh Wood. Crowns merge into one large canopy extending across the site boundary to ground level within the site. Low roost potential. No structural faults visible from ground level	Retain. Canopy and RPA extending across the site boundary will require protection measures.	A2	5.4
G8	Leylandii <i>XCupressocyparis Leylandii</i>	16	<300	2m on south side	0	M	20	F	Line of closely planted upright leylandii merging into a vertical screen. Trimmed on both side. Negligible roost potential. No structural faults visible from ground level	Retain. RPA will require protection within the field.	B2	3.6
T9	Holly <i>Ilex aquifolium</i>	6	275	2m on south side	0	SM	10	F	Single trunk supporting as fairly upright ascending canopy within an adjacent garden. Negligible roost potential. No structural faults visible from ground level	Retain. RPA will require protection within the field. No canopy work is required.	C2	3.3

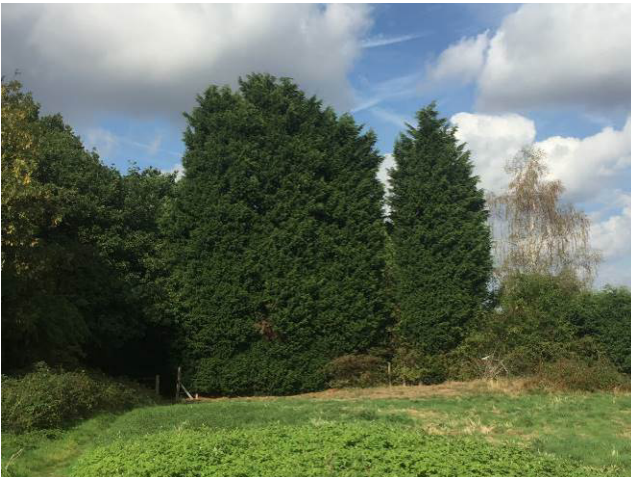
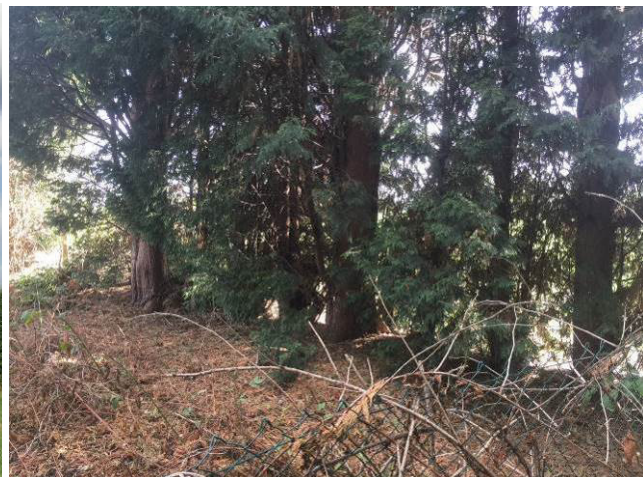
Group G8 comprise a linear group of closely planted Leylandii trimmed along the sides to form a vertical screen along the southern boundary of a residential garden outside of the site area. These trees are placed within Category B. They are not of large stature but do provide excellent screening to the adjacent garden.

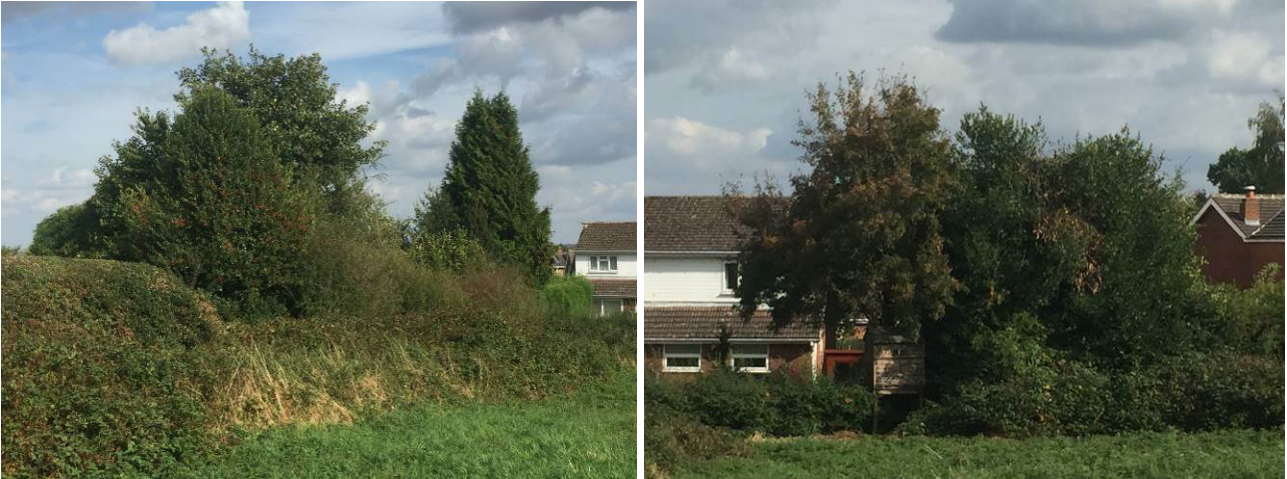
Trees T9 – T11 are small Holly and Leylandii positioned within adjacent gardens close to the boundary of the field but outside of the site boundary. None are specimens of significant stature but all are visible from within the field interior and provide some screening to the adjacent gardens supported by trimmed hedgerows. Leylandii T10 is placed within Category B and Holly T9 and T11 are placed within Category C. The RPAs of these trees extend across the site boundary and will require protection measures.

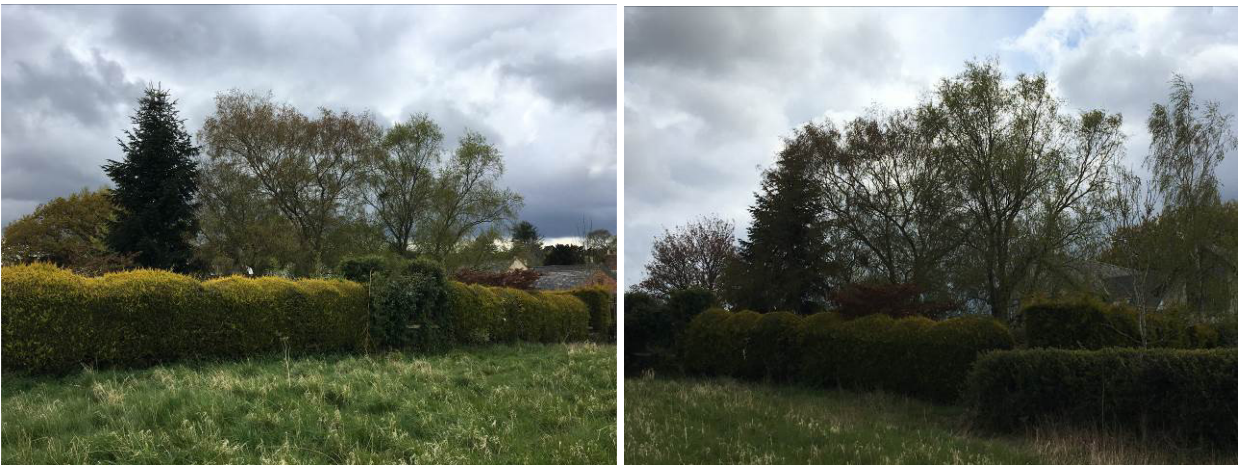
Trees T12 - T14 are situated in the garden of a property to the south of the site area outside of the site boundary. These trees are Birch, Oak and Spruce of significant stature. The canopies do not extend across the site boundary and the trees are between 7m and 8m from the boundary. All three trees have been placed into Category B.

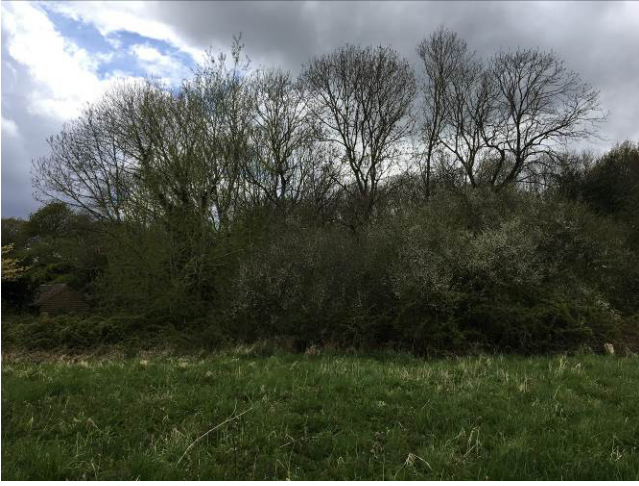
Trees T15 – T18 comprise Oak and Ash situated on the south-western boundary of the site on the margin of the adjacent woodland area Group G7. These trees are set some distance back from the site boundary which is screened by dense suckering Blackthorn but could be assessed from the public footpath within the woodland. These trees are predominantly Category B but with one category C specimen.
