BS5837:2012 Tree Survey
 Land west of Leconfield Road
 Loughborough
 Leicestershire
 NGR SK50951 17549

SAFETY SCHEMES IN PROCUREMENT	Report prepared by: C Barker	Date Issued: 23 November 2020
		Report Version: Final
	Reviewed by: KLB	
	Report ref: P2164 /1020 /02	C B E Consulting Highbank, 5 Grantham Road, Navenby Lincoln. LN5 0JJ. Telephone (01522) 810086. www.cbeconsulting.co.uk

BS5837 Tree Survey, Land west of Leconfield Road

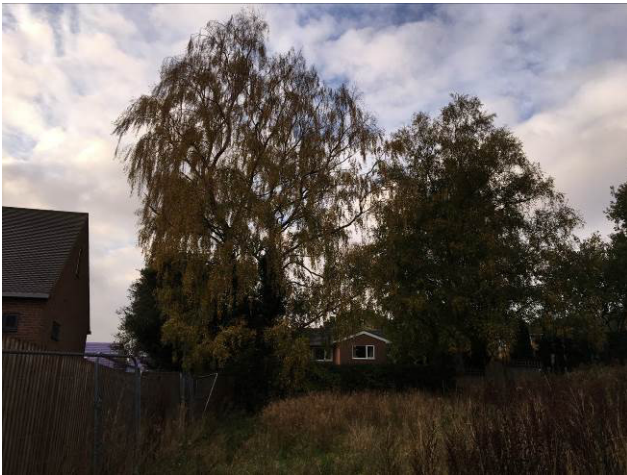
T1 – T2

Trees T1 – T3 comprise two Birch trees of Category B and one Oak of Category A positioned within a garden approximately 1m to the south of the field boundary. These trees provided canopy cover and partial screening to the garden supported by a trimmed Hawthorn hedge. These are trees of good quality and the canopies extend across the field boundary at height. It is unlikely any facilitation pruning will be required but the RPA's will need to be protected.

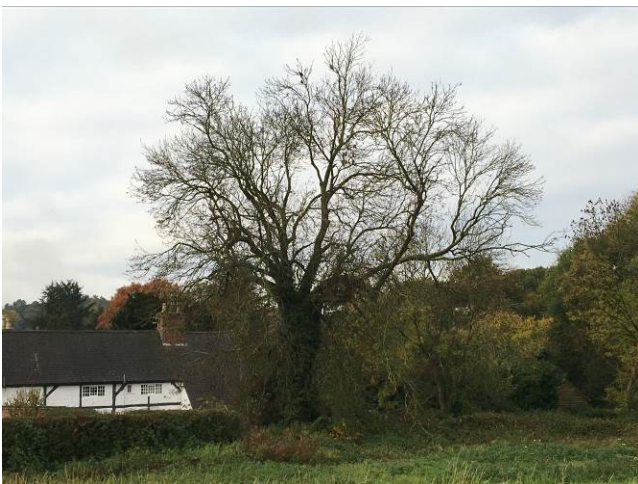
Trees T4 and T5 are situated in adjacent land close to the south western corner of the site. Ash T4 is a large mature tree of significant stature placed within Category B. The RPA and canopy of this tree extend across the field boundary and will require protection measures. Willow T5 is a small tree of little landscape significance that present no constrain to development and it is placed within Category C.

T4	Ash <i>Fraxinus excelsior</i>	18	765	8m on north side	5	M	20	F	Single trunk within an adjacent garden supporting a very broad irregular spreading canopy. Negligible roost potential. No structural faults visible from ground level	Retained. Protect the canopy and RPA on the north side with fencing. No canopy work required.	B2	9.1

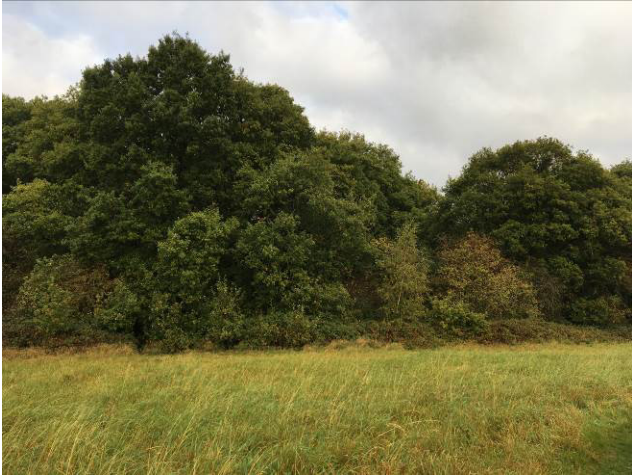
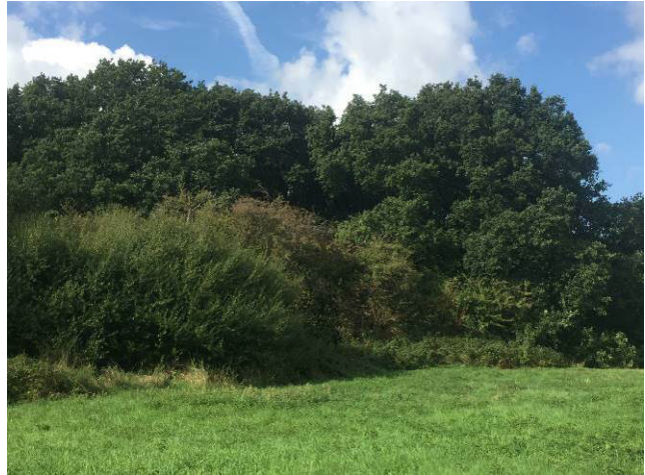
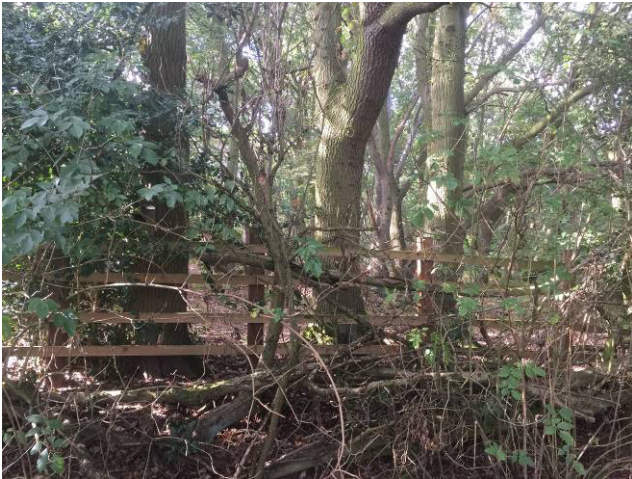
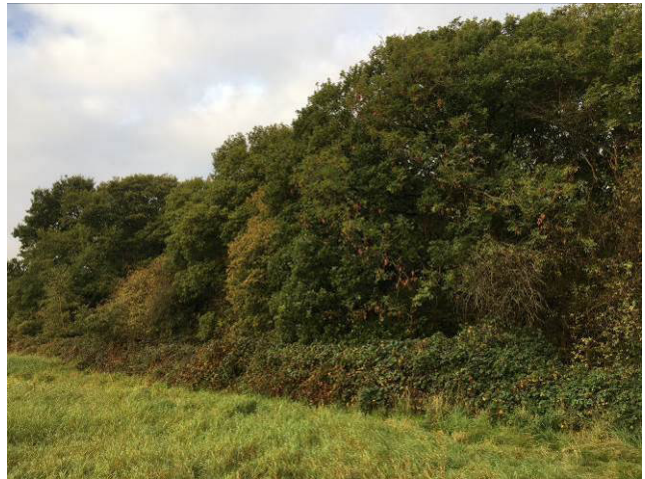
Trees T6 and Group G7 comprise mature Oak along the boundary of Burleigh Wood. These are trees of significant stature with many other mature trees further to the west forming a large woodland area. These trees are highly visible from within the site and adjacent residential houses and are placed within Category A. The crown extents and RPA extend across the site boundary and protection measures will be required.

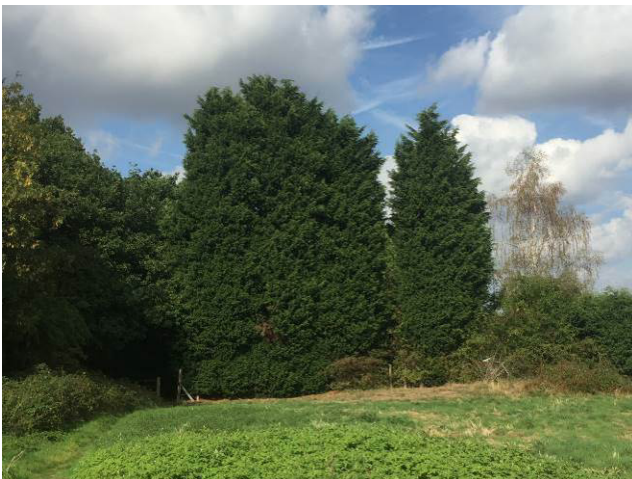
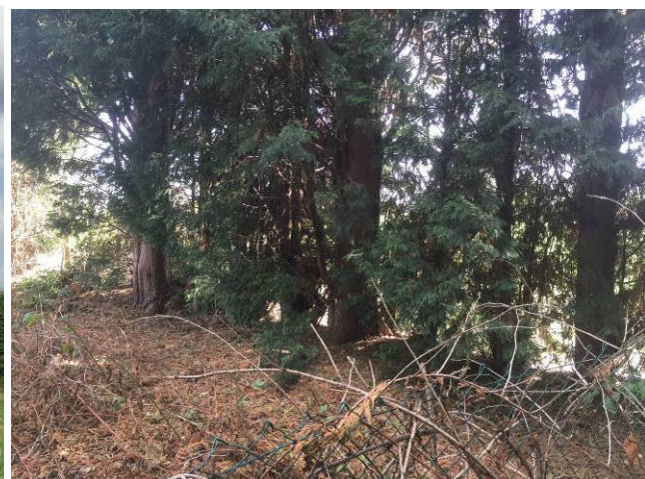
Group G8 comprise a linear group of closely planted Leylandii trimmed along the sides to form a vertical screen along the southern boundary of a residential garden. These trees are placed within Category B. They are not of large stature but do provide excellent screening to the adjacent garden.

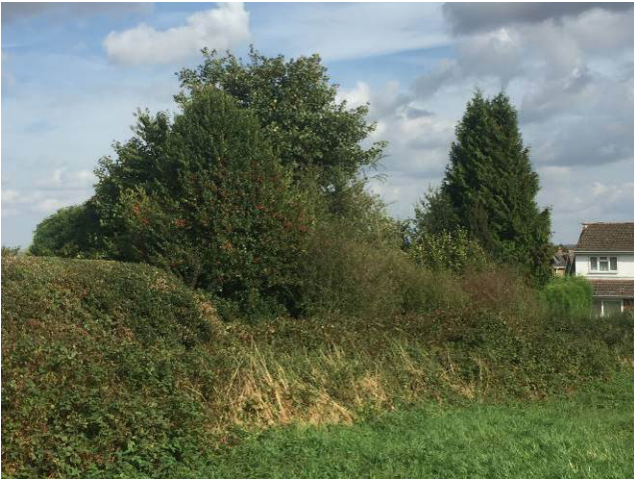
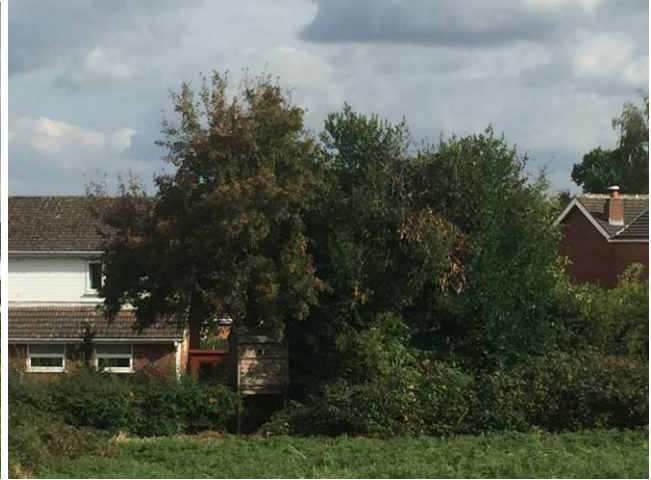
Trees T9 – T11 are small Holly and Leylandii positioned within adjacent gardens close to the boundary of the field. None are specimens of significant stature but all are visible from within the field interior and provide some screening to the adjacent gardens supported by trimmed hedgerows. Leylandii T10 is placed within Category B and Holly T9 and T11 are placed within Category C. The RPA's of these trees extend across the site boundary and will require protection measures.
