Appendix 7 - Email from the Environment agency with photographs attached dated 9 July 2019

RE: Test

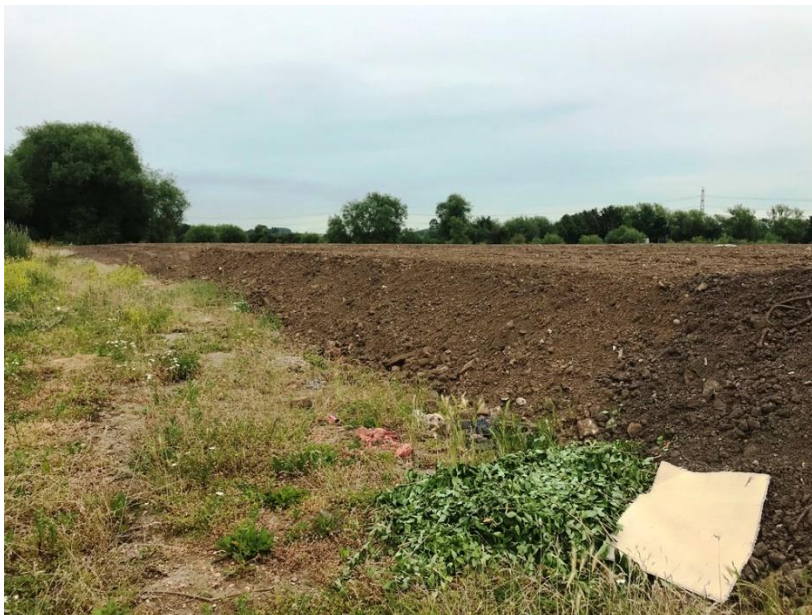
I have had a look at the site this morning and there is still a large amount of soil that has been used to raise the ground height, our flood mapping is attached. The site comprises elements of FZ3a / 3b and FZ2. The fact that some of the ground raising seems to have taken place in FZ3b (green area on the map) should be concerning as this is the functional floodplain so has a high probability of flooding, flood water which would now be pushed elsewhere do to the ground raising.
