Taylor Wimpey Strategic Land

Land North of Barkby Road, Syston, Leicestershire

Phase 1 and 2 Geo-Environmental Site Investigation

Project no. 302001 R01 (01)

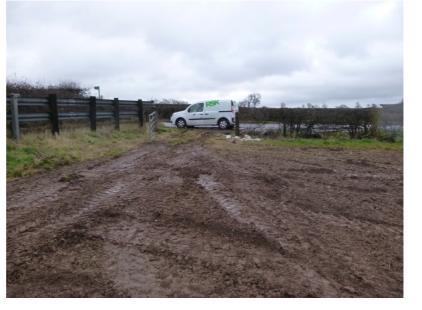
Photo No. Date: 4 22.02.18

View towards the south west showing the draining ditch running between the southern and central field. The flowing water goes through a culvert under the access between the two fields.

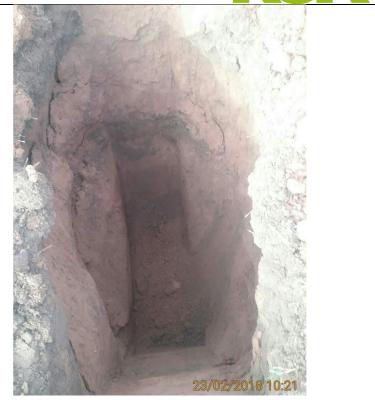
Photo No. Date: 10 22.02.1

Unstable sides of TP02 due a slightly gravelly clayey fine to medium SAND (also found in TP01 and WS01).

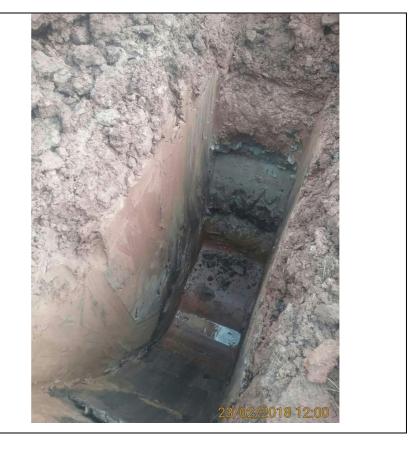
Photo No. Date: 11 22.02.18

TP01 showing topsoil overlying a clayey slightly gravelly SAND (Birstall Member), with a slightly sandy CLAY at depth (Branscombe Mudstone Formation).

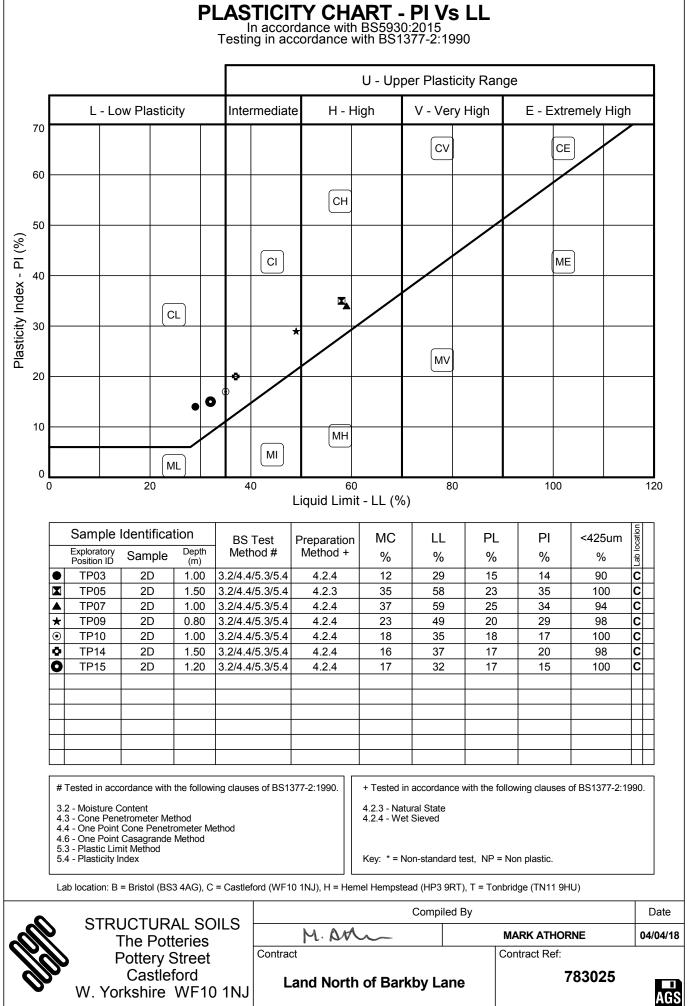
Exploratory Position ID	Sample Ref	Sample Type	Depth (m)	Moisture Content %	Liquid Limit %	Plastic Limit %	Plasticity Index	% <425um	Description of Sample	
TP03	2	D	1.00	12	29	15	14	90	Red brown slightly sandy slightly gravelly CLAY	
TP05	2	D	1.50	35	58	23	35	100	Grey brown CLAY	
TP07	2	D	1.00	37	59	25	34	94	Grey brown slightly sandy slightly gravelly CLAY	
TP09	2	D	0.80	23	49	20	29	98	Red brown slightly sandy slightly gravelly CLAY	
TP10	2	D	1.00	18	35	18	17	100	Red brown slightly sandy slightly gravelly CLAY	
TP14	2	D	1.50	16	37	17	20	98	Red brown slightly sandy slightly gravelly CLAY	
TP15	2	D	1.20	17	32	17	15	100	Red brown slightly sandy slightly gravelly CLAY	
		RUCT		Contra	act:			Lan	d North of Barkby Lane	Contract Ref: 783025

A selection of eight disturbed samples were taken from the exploration holes advanced at the site and sent for geotechnical analysis. Geotechnical testing included liquid and plastic limit testing and moisture content testing on cohesive soils and particle size distribution testing on granular soils. The laboratory results for geotechnical testing are included within Appendix J.
