David Wilson Homes

Barkby Road Junction, Queniborough

Arboricultural Impact Assessment & Method Statement

August 2022

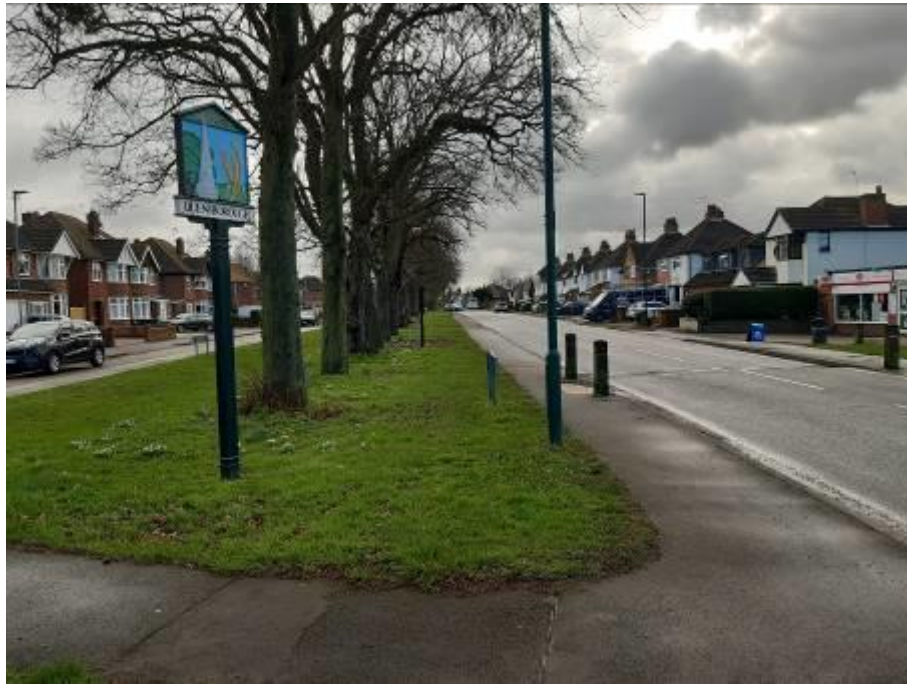
Photograph 2: Tree cover along Queniborough Road

- 4.16 Trees T13 – T20 stood within the same grass strip as trees T3 – T12 but were located to the north of Queniborough Road and to the south of The Ringway. Trees along this section were generally in better condition than the trees adjacent to Rearsby Road through the lack of significant defects despite having also been subjected to branch pruning to lift crowns over the adjacent highways and footpaths. All but two trees within this section were of moderate quality housing few significant defects of note.

- 4.17 T20, a mature Locust tree *Robinia Pseudoacacia*, showed significant dieback amongst the outer canopy with past reduction work removing a number of dead branches and a retrenched inner crown and a large amount of suckers at the base of the tree.

- 4.18 T19, a mature horse chestnut, had sustained an area of damage from ground level to 1.8 m exposing the heartwood. The wound may have possibly been caused by vertical cracking of a bark through expansion naturally but was approximately 100 mm wide which would seem to suggest physical damage occurring by other means. The remains of a decay fungus, possibly *Cerioporus squamosus* were also observed to the base of the tree. Despite these defects T19 was considered to be of moderate quality and retention category B.

- 4.19 T21 was an early mature London *Platanus x hispanica* situated to the south of the Queniborough Road and Barkby Road junction within an area of open grass. The crown was brought be spreading and supported by three major primary branches from approximately 1.3m of ground level. No significant defects were observed at the time of the assessment and therefore T21 was considered retention category A.

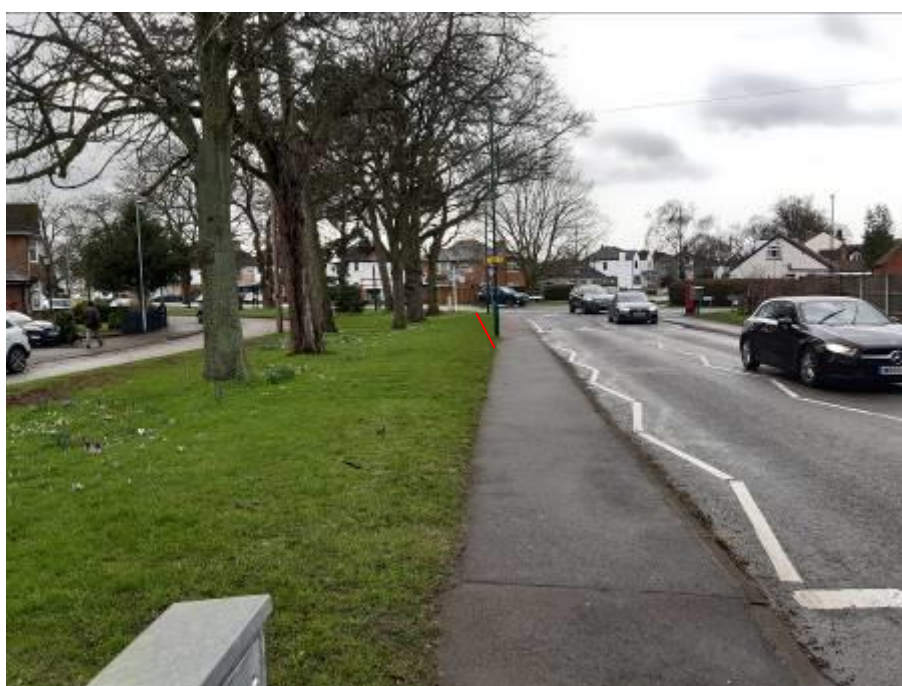
Photograph 3: Approximate line of proposed highway

- 5.5 If these works are carried out under the supervision of an Arboricultural Clerk of Works, then the impacts to retained trees are not considered to be detrimental to the long-term health and successful retention. Following the request by Leicestershire County Council (LCC) any works will also be carried out under the presence of a member of LCC's Forestry & Arboriculture Group.

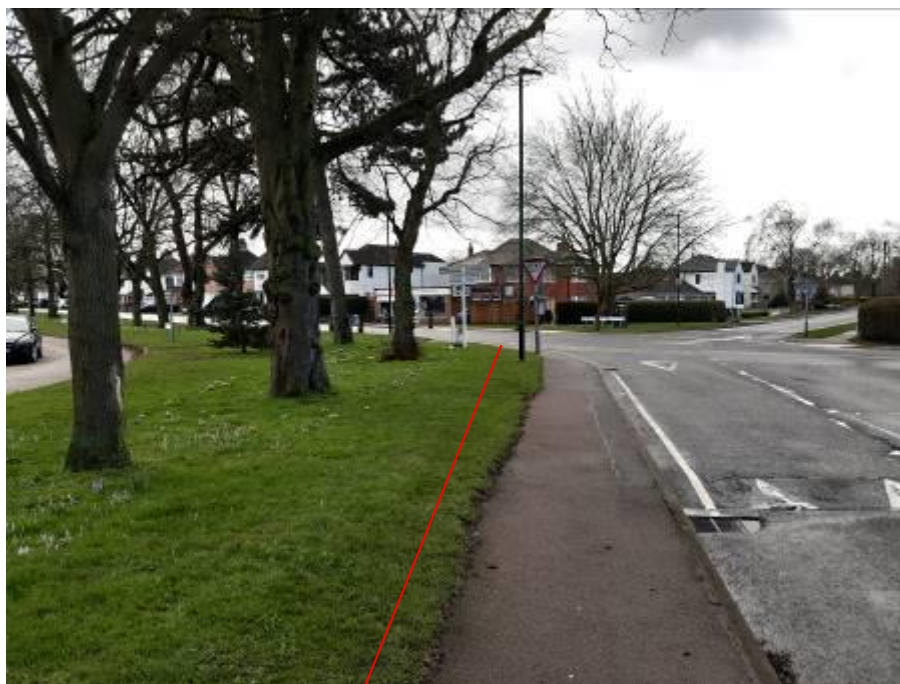
Photograph 4: Approximate line of proposed highway next to T11 to T13

- 5.6 The removal of T12, a low-quality common lime tree is recommended due to the close proximity of the widened highway to the base of this tree. However, comments received from LCC have requested that the tree is retained as its removal will break up the continuity of the avenue. It should still be noted that the current declining health of this tree means that any potential impacts will be greater to the long-term health. The loss of this tree from within the current street scene is not considered to be detrimental on arboricultural grounds and would benefit the future growth of the surrounding trees of high quality. If the tree is to be retained, then LCC have suggested that judicious pruning is carried out after construction where required.

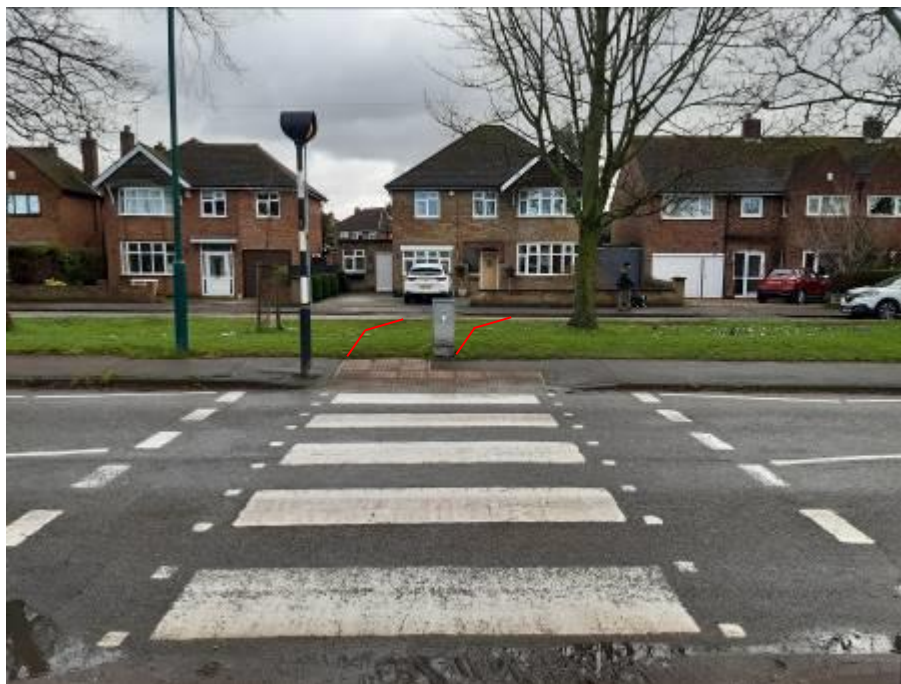
Photograph 5: Approximate location of Cellular Confinement Footpath

- 5.9 The alignment of a footpath link to the north of T6 will pass through the calculated rooting area of both T5 & T6 and is in close proximity of the newly planted memorial tree. The construction will require the use of a cellular confinement system to allow passage over the roots without impacting these trees. There will be the requirement for some excavation to tie into existing levels.

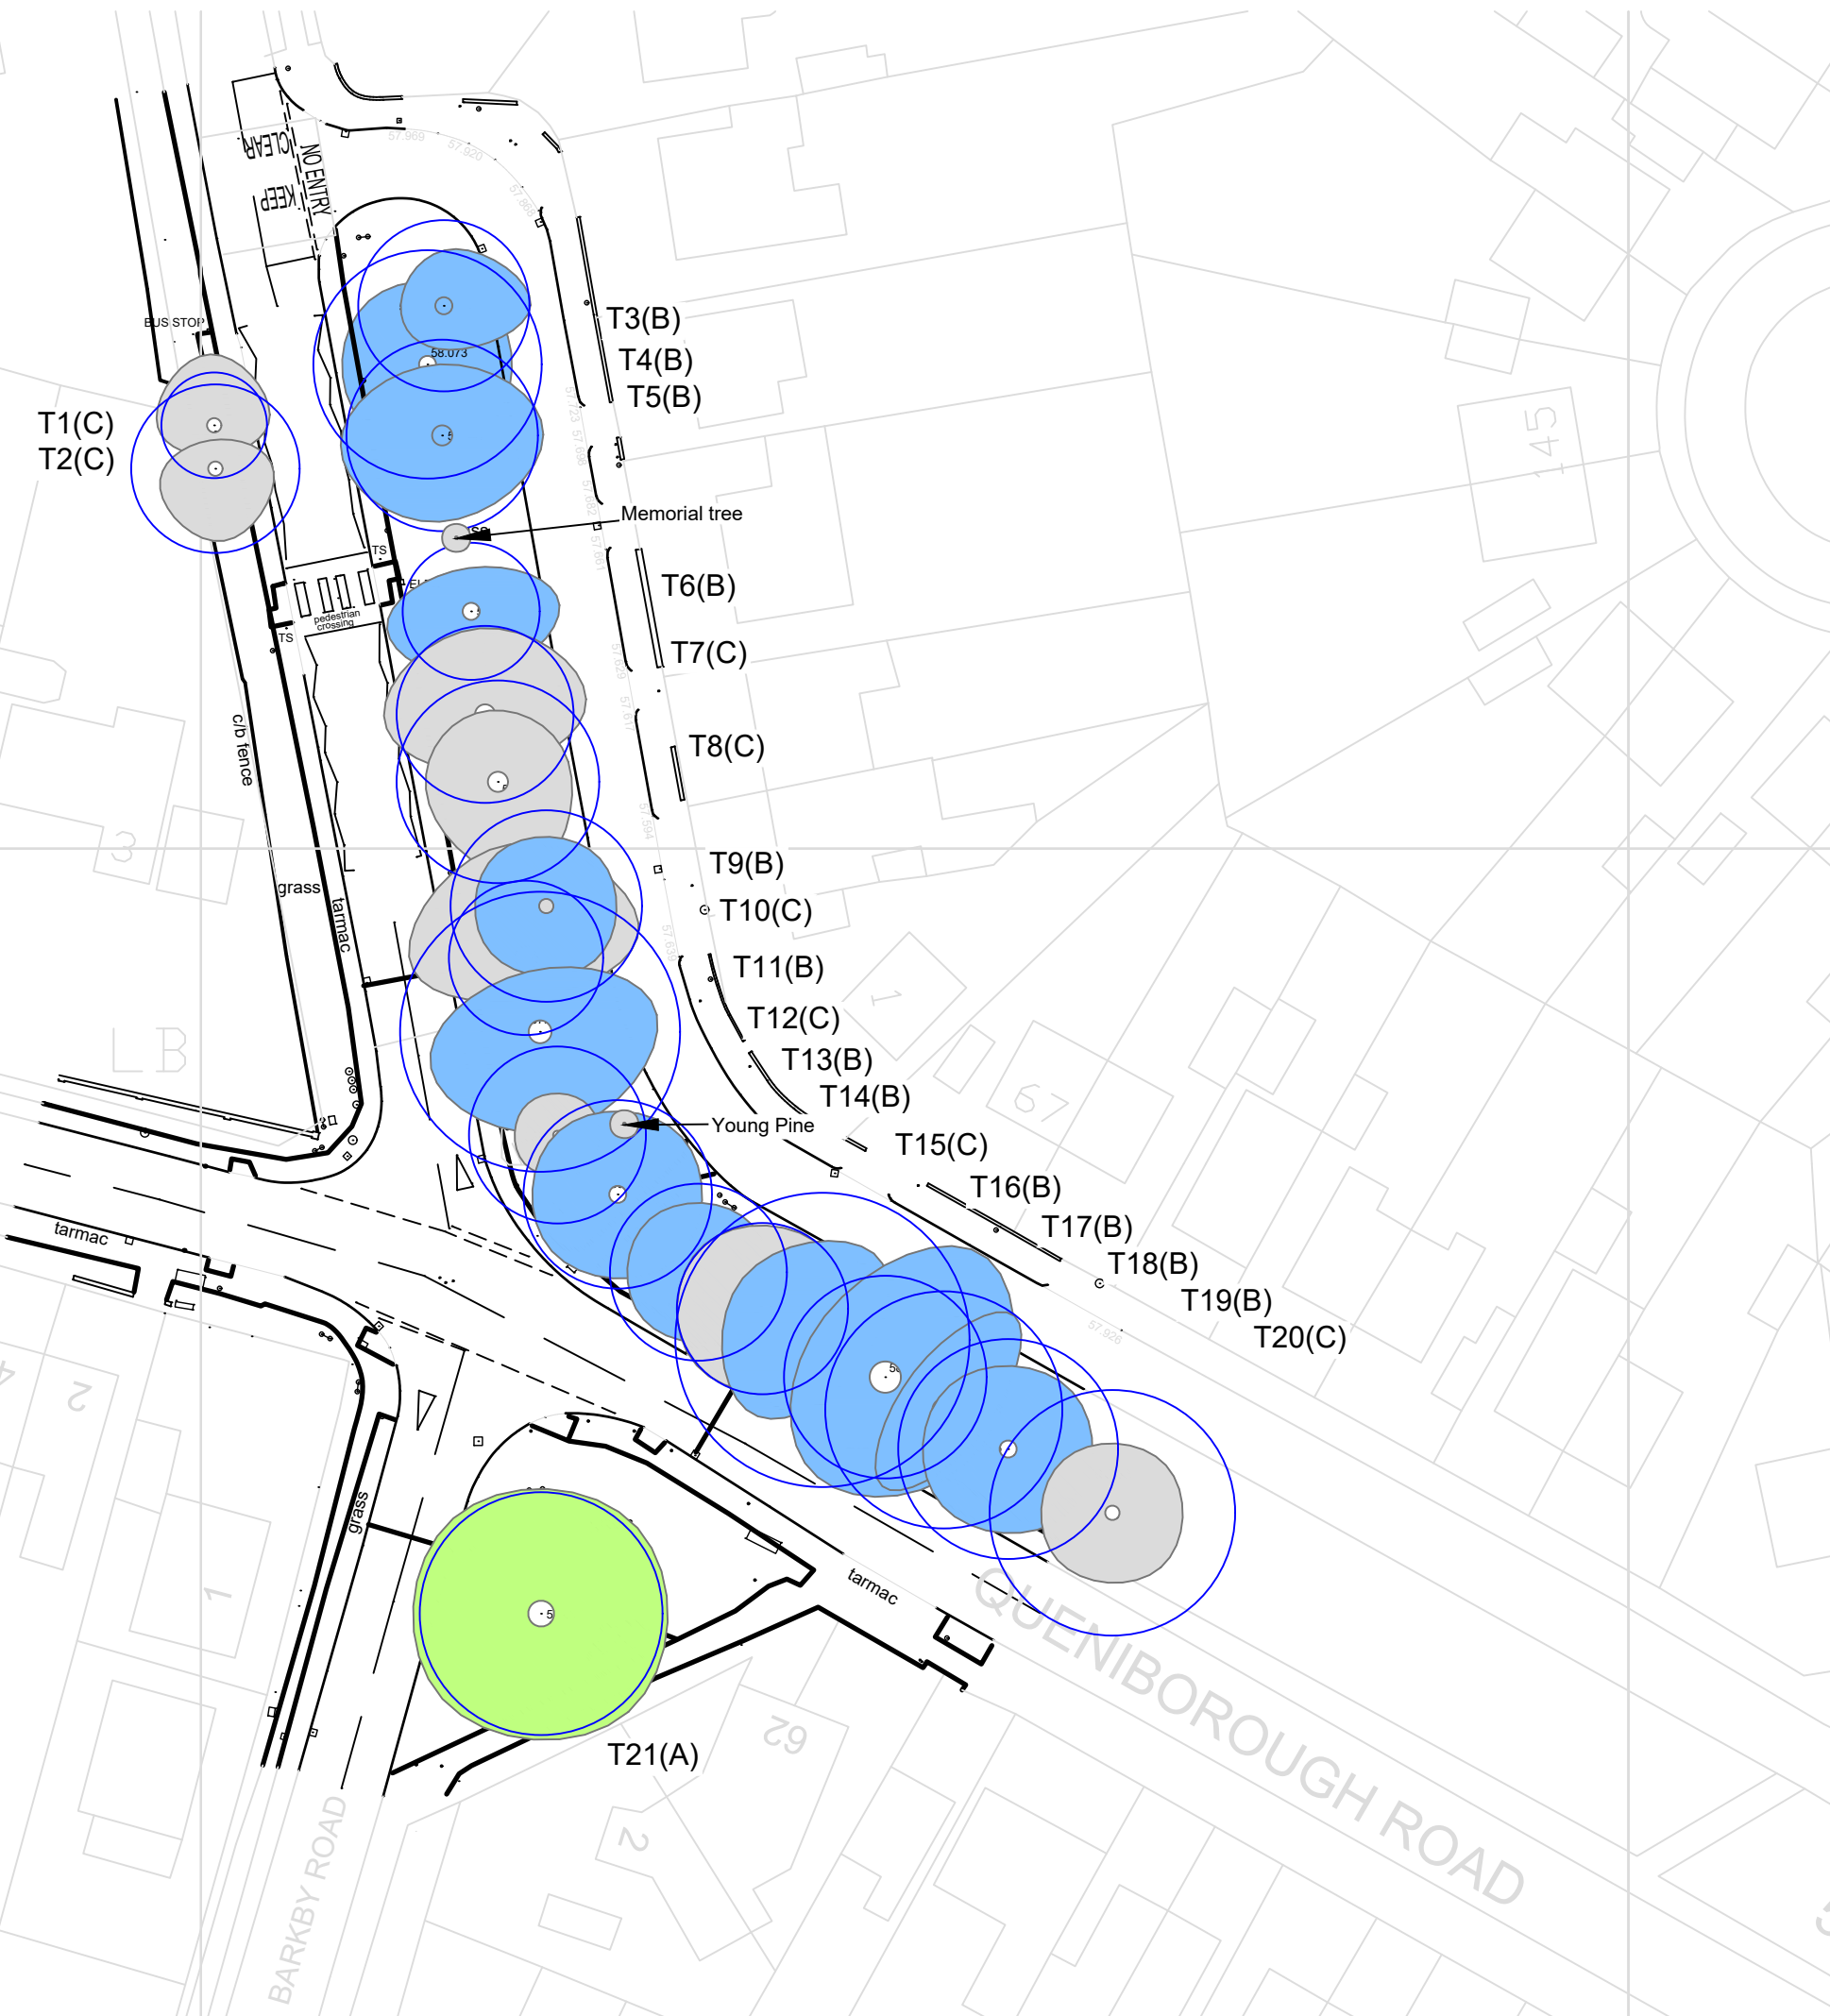
- 4.1 A total of twenty-one individual trees were surveyed as part of the Arboricultural Assessment. Trees were surveyed as individual trees and groups of trees where examples are clearly present as per the description. Refer to the Tree Survey Plan and Appendix A – Tree Schedule for full details of the trees included in this assessment. The table below summarises the trees assessed.
- 4.2 Several of the trees have been discussed in more detail following the table, owing to their physical condition or arboricultural significance.

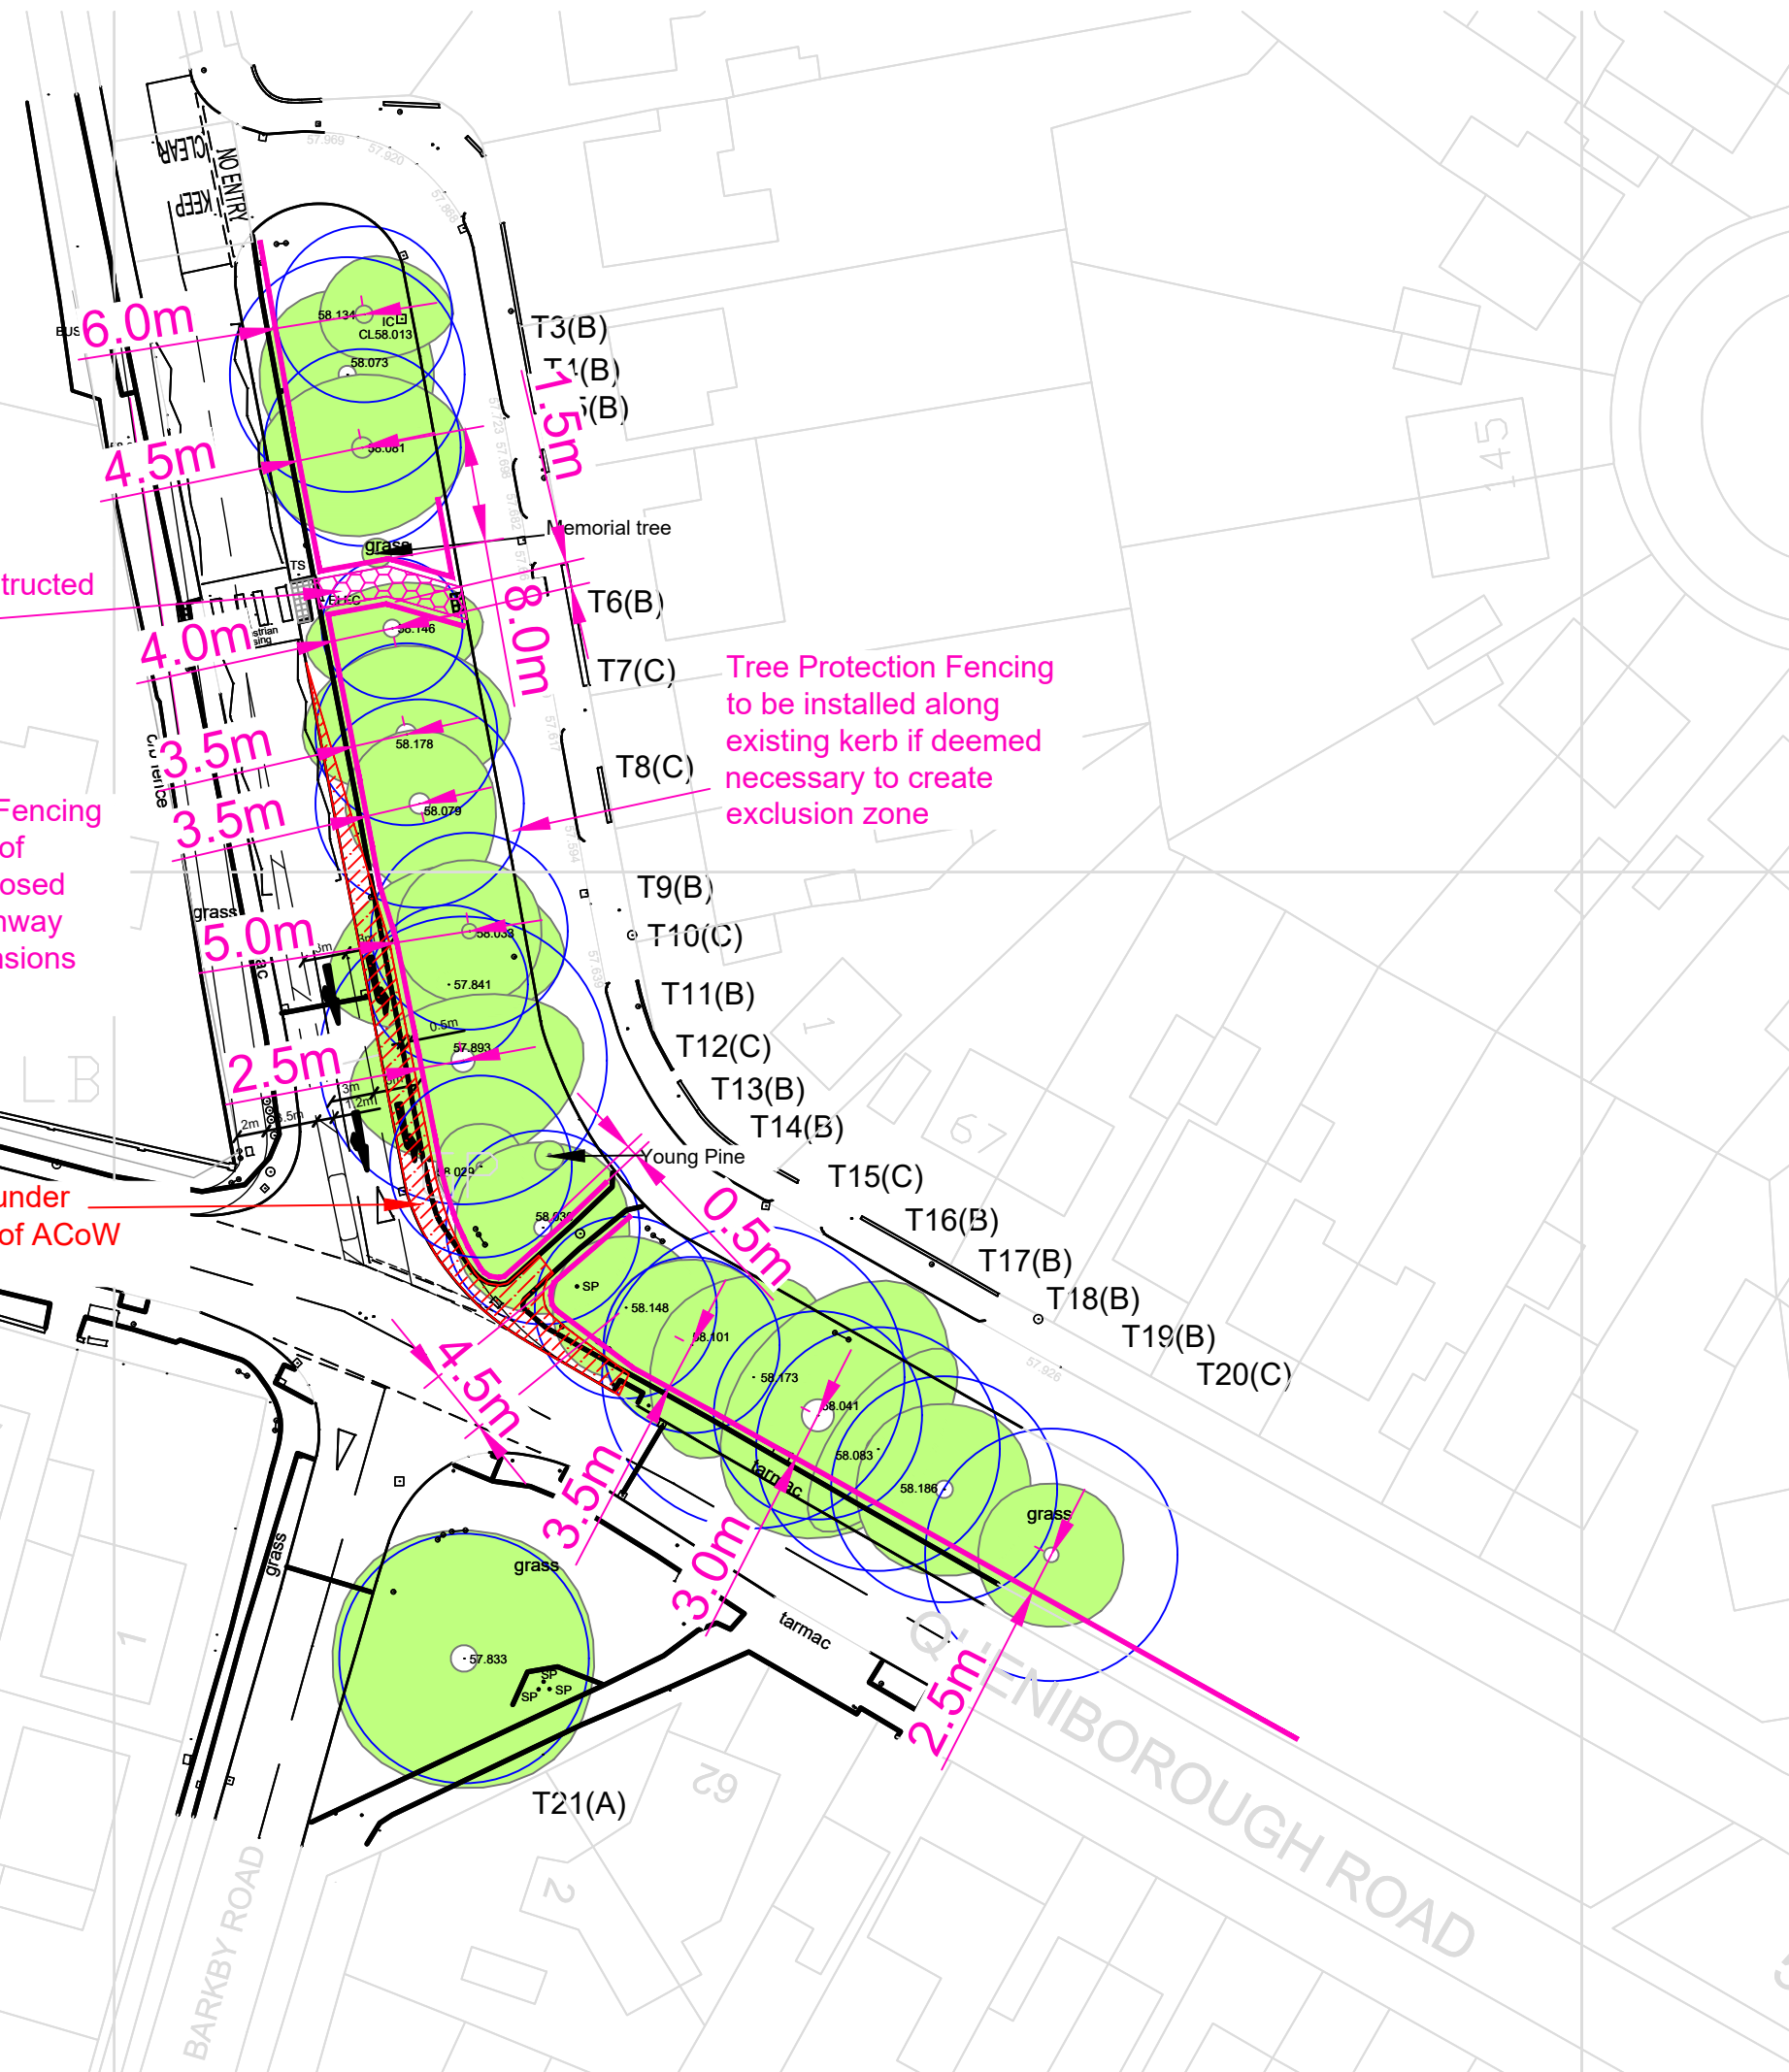
Excavation under supervision of ACoW and LCC

Tree Protection Fencing to be installed along existing kerb if deemed necessary to create exclusion zone

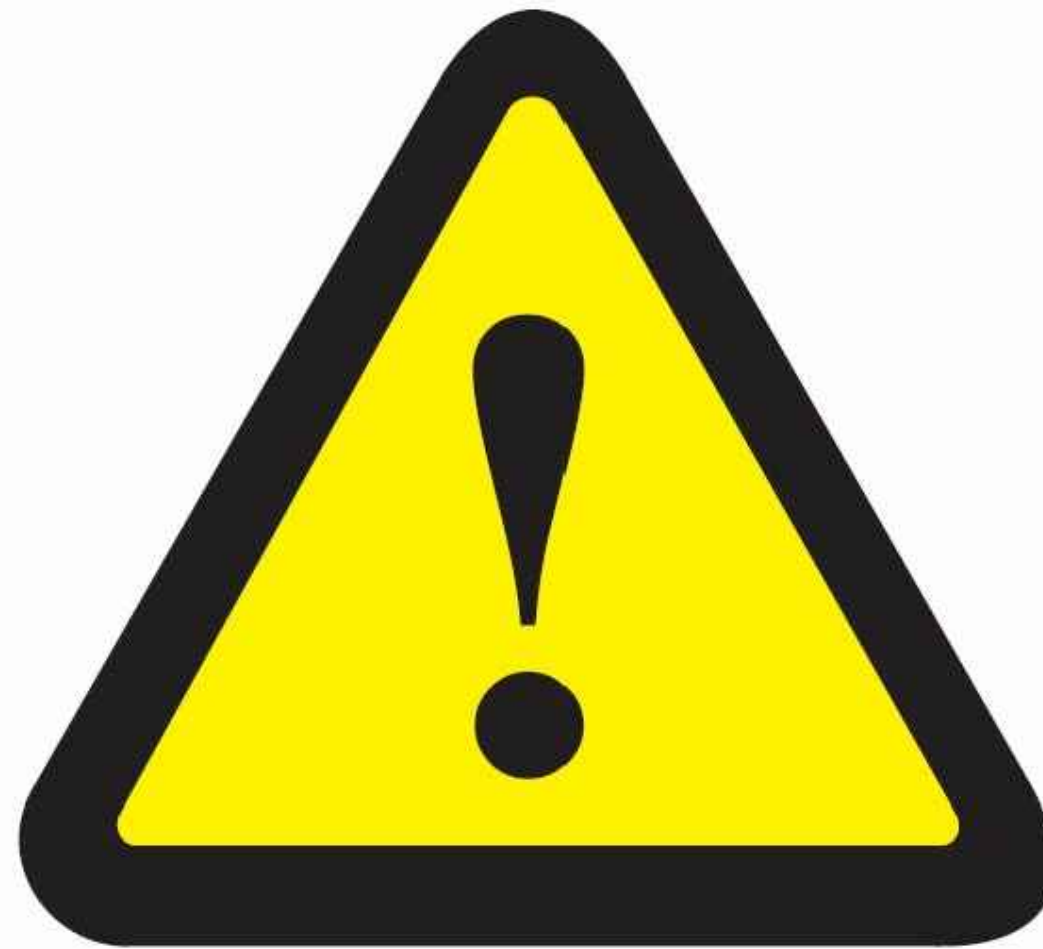
PROTECTIVE FENCING. THIS FENCING MUST BE MAINTAINED IN ACCORDANCE WITH THE APPROVED PLANS AND DRAWINGS FOR THIS DEVELOPMENT.

**TREE PROTECTION AREA
KEEP OUT !**
(TOWN & COUNTRY PLANNING ACT 1990)
**TREES ENCLOSED BY THIS FENCE ARE PROTECTED BY PLANNING CONDITIONS AND/OR ARE THE SUBJECTS OF A TREE PRESERVATION ORDER.
CONTRAVENTION OF A TREE PRESERVATION ORDER MAY LEAD TO CRIMINAL PROSECUTION**
ANY INCURSION INTO THE PROTECTED AREA MUST BE WITH THE WRITTEN PERMISSION OF THE LOCAL PLANNING AUTHORITY

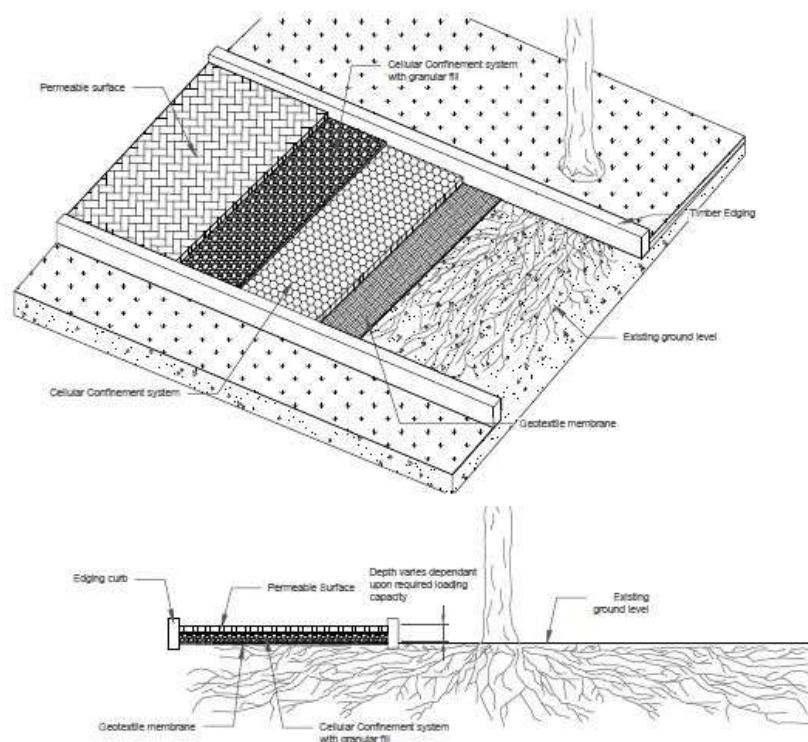
Figure 1: No-dig Footpath Construction

Figures 1 and 2 demonstrate the specification for No-dig Footpath Construction and No-dig Permanent Road Construction (further details and product specifications are available upon request).

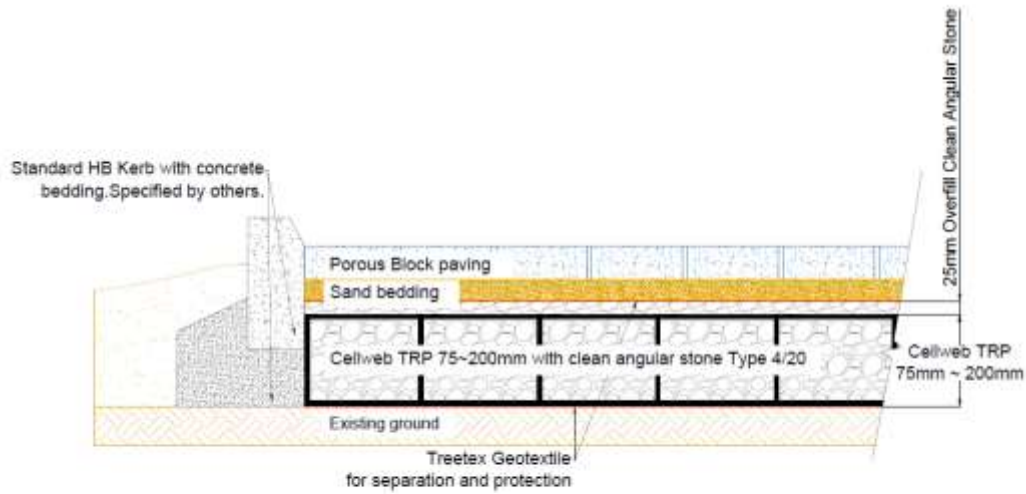
Figure 3: Geosynthetics Cellweb 75-200mm Block Paving Standard Detail

Figure 3 and Appendix E provides information from a reputable supplier (Geosynthetics Ltd).

Note: Subbase could be required depending on the existing ground CBR % and the type of traffic on the surface.

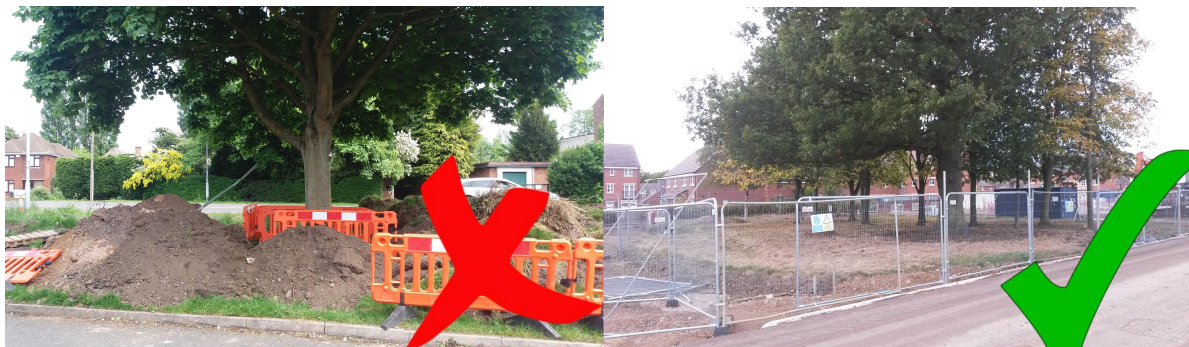
Unacceptable example of tree protection due to a lack of adequate fencing and poor site management. Note mounds of soil have been placed within the Root Protection Area.

Tree Protection Fencing which has been erected prior to the commencement of any site works and the correct signage has been provided to clearly highlight that this is a protected zone.

3. **Report** any instances where the fencing has been removed, repositioned, damaged or is not fit for purpose (see images below) to the Site Manager. This shall help the Site Manager to ensure that the fencing is maintained throughout the construction process. It will also reduce the risk of any staff and contractors accidentally and inadvertently causing damage to trees as a result.

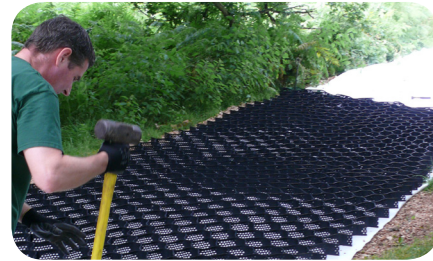
Step 3: Lay out Cellweb® TRP

- Cellweb® TRP is a NO DIG tree root protection measure and it is recommended that no excavation be performed without prior approval and guidance from the Local Authority Arboricultural Officer.
- Soil compaction from vehicles, machinery and materials is to be strictly prohibited during construction within Root Protection Areas (RPAs).
- Approval must be obtained from the Local Authority that the design and the method of construction is acceptable.
- Further information is available from the following two documents;
 - British Standard BS5837: 'Trees in Relation to Design, Demolition and Construction' (2012).
 - Arboricultural Advisory and Information Service: Practice note 12 – 'Through the Trees to Development' (APN12).

3. Lay out the Cellweb® TRP Cellular Confinement System

- Lay out the collapsed Cellweb® TRP on-top of the Treetex™.
- Place one of the supplied J pins into the centre cell at the end of the panel and secure into the ground.

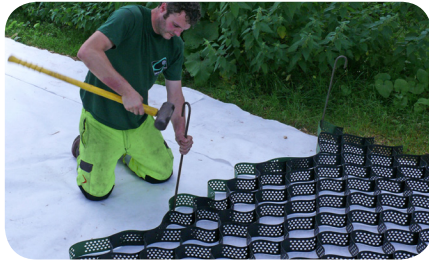
Step 3: Pinning Cellweb® TRP

- Pull out the Cellweb® TRP to its full 8.1m length and secure its length with another J pin.

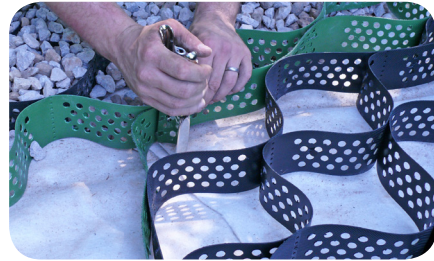
Step 3: Stapling Cellweb® TRP

- This will produce a cell size of 259mm x 224mm which is the required cell aperture. Each cell must be fully extended and under tension.
- Staple adjacent panels together at each cell (see Note 3).
- If a curved path or shape is required, this should be cut when the Cellweb® TRP panel is pinned out to 8.1 x 2.56m, ensuring complete cells remain. Do not try to curve or bend the Cellweb® TRP panels into place.
- When cutting Cellweb® TRP, please bear in mind that you will lose two internal cells per cut. Across a 8.1m long panel, this equates to a loss of 0.224m x 2 along the length or 0.259m x 2 across the width.

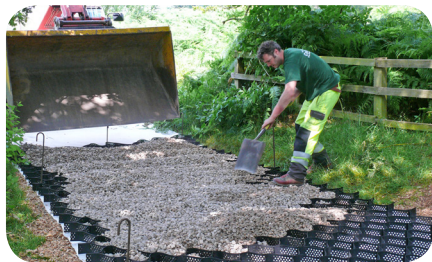
Step 4: Clean Angular Stone

4. Infill the Clean Angular Stone
