Stage 1 Road Safety Audit

Barkby Road, Syston

Proposed Residential Access

Reference: RSC/EB/DL/22014

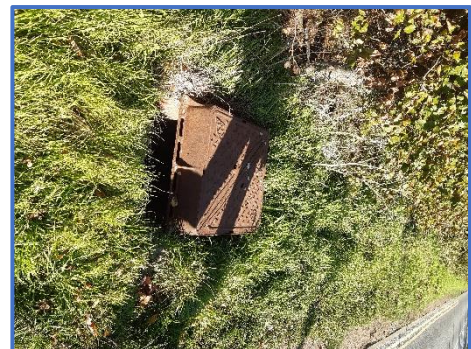
Location: Western end of footway near tie
in with Empingham Drive.

Summary: Large Service cover may be a
slip hazard for pedestrians

There is a large service cover which will fall within the proposed footway. The metal service cover may pose as a slip hazard for pedestrians particularly during wet conditions.

It is recommended that the service cover should be replaced with an infill cover containing the same material as the surrounding footway.

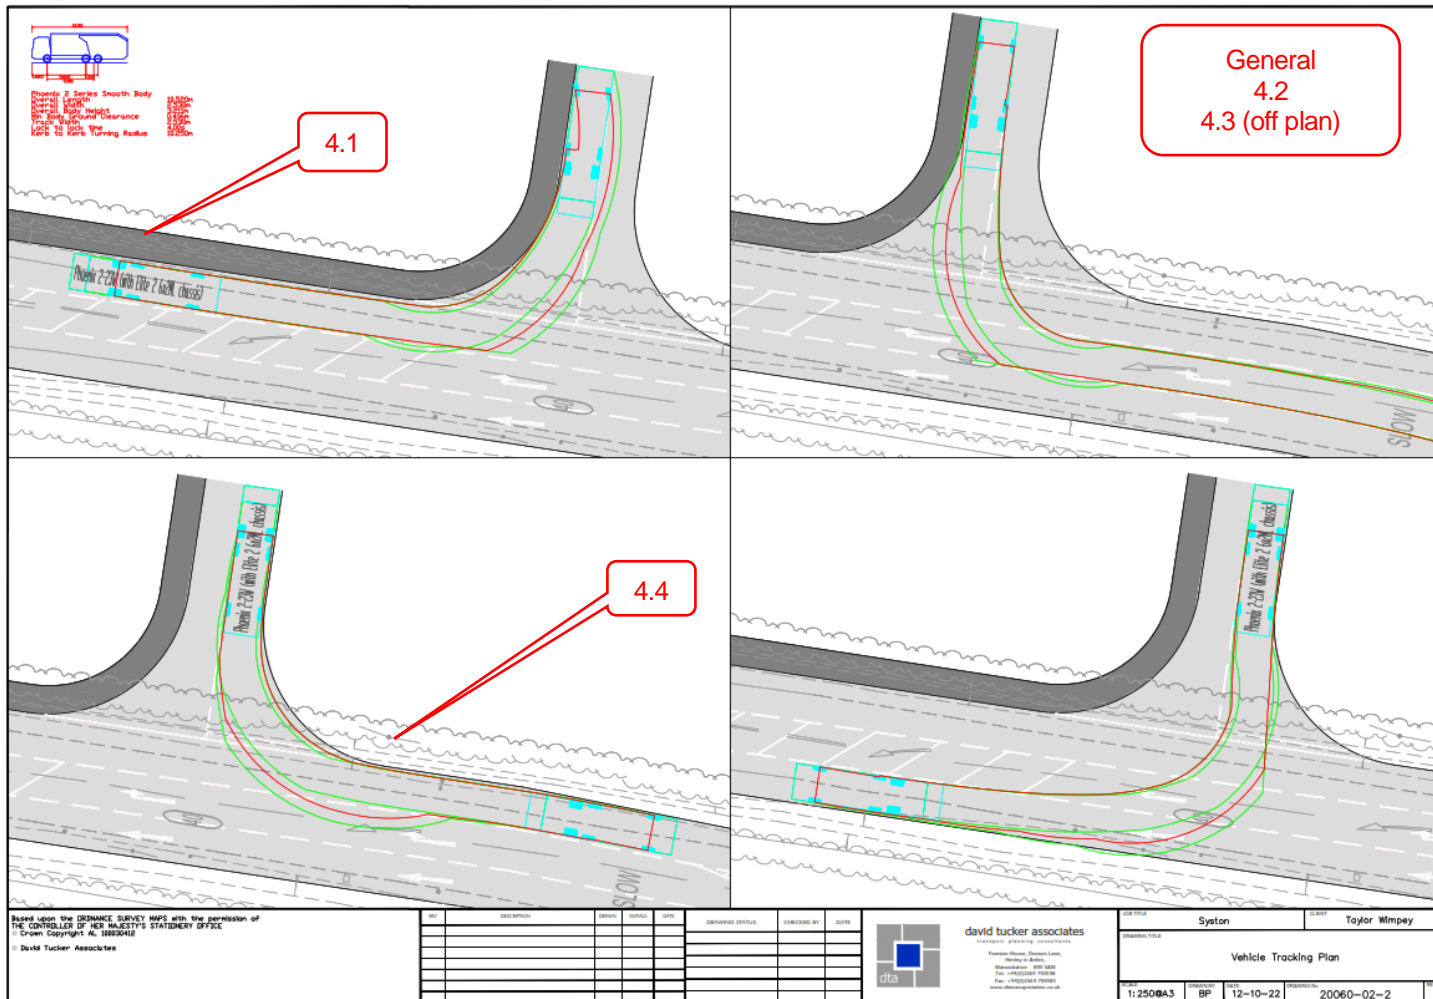
APPENDIX 2: Drawing Showing Problem Locations

Problem numbers shown on the attached drawing refer to Problem numbers within the report.
