Land off Leconfield Road
Nanpantan

Phase II Exploratory Investigation Report

Bowbridge Homes Limited

Project No: 40056-2		Date: 8 th September 2020	
Issue/revision	Prepared by	Checked by	Approved by
	Nina Copson BSc (Hons) MSc FGS Geo-Environmental Engineer	Jason Hollands BSc (Hons) MSc MEnvSc CGeol FGS Director	Jason Hollands BSc (Hons) MSc MEnvSc CGeol FGS Director

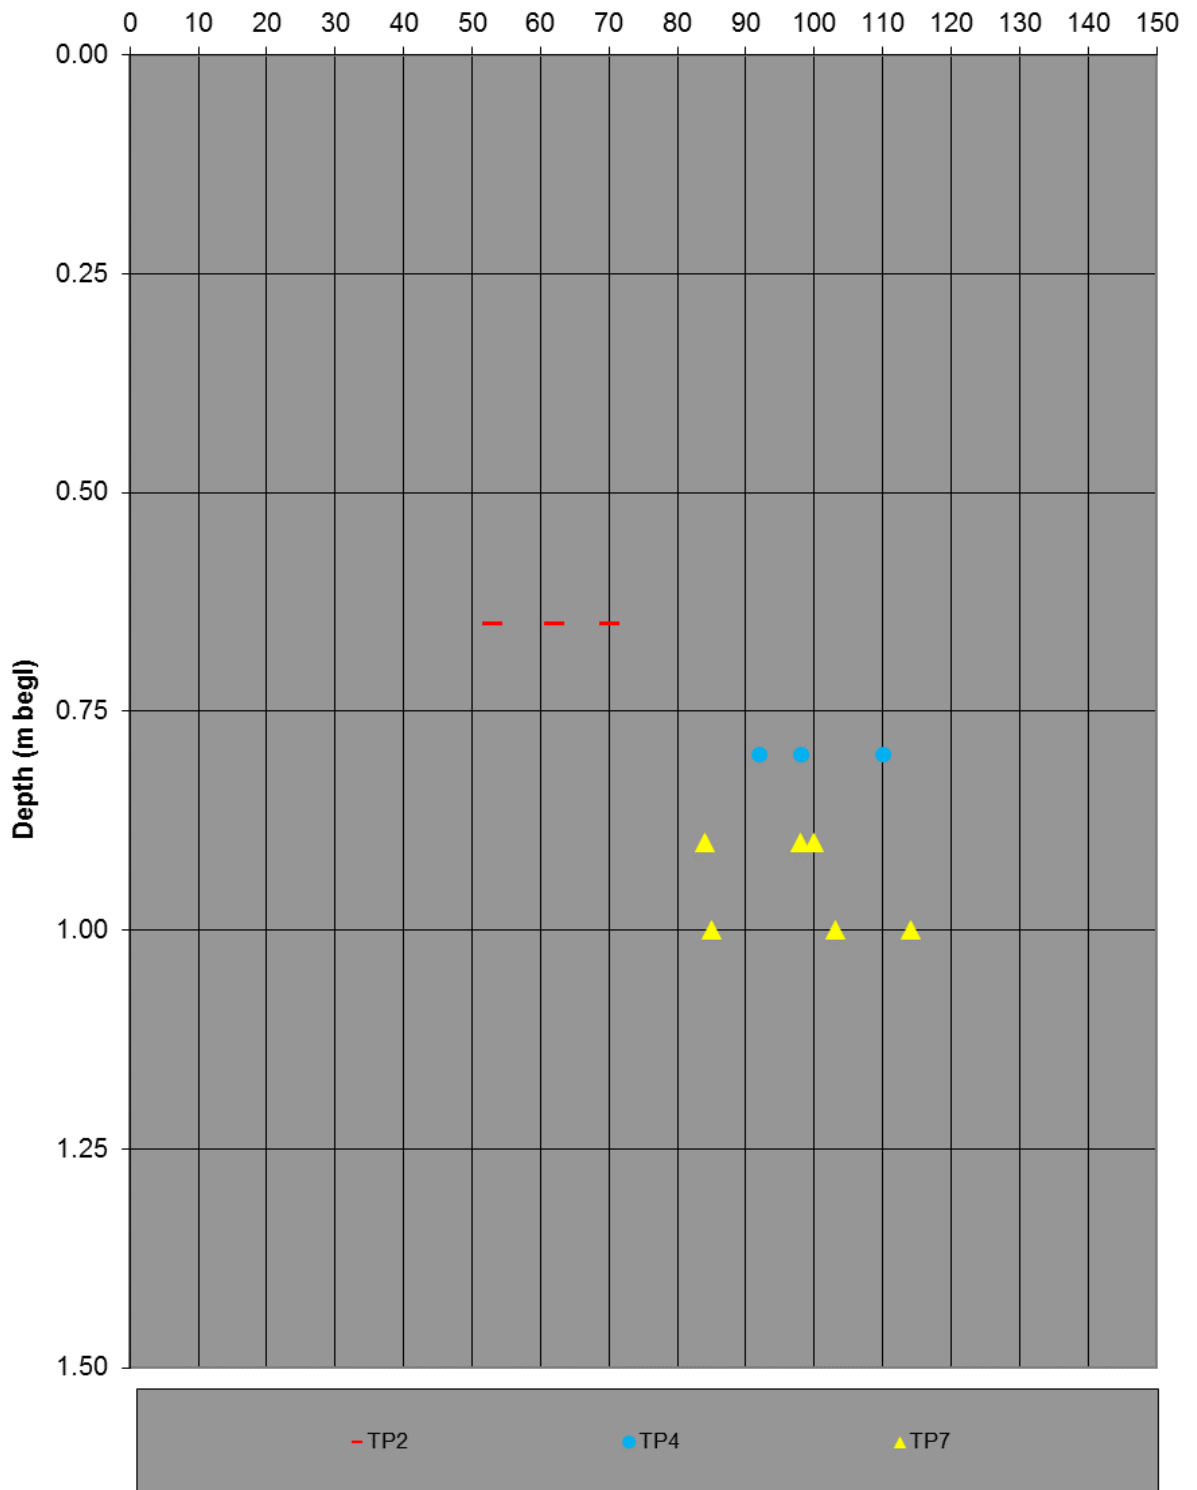
Chart 40056/01
Leconfield Road, Nanpantan
 Shear Vane Values Vs Depth (m begl)

In Situ & Ex Situ Shear Vane Value (kN/m² - uncorrected)

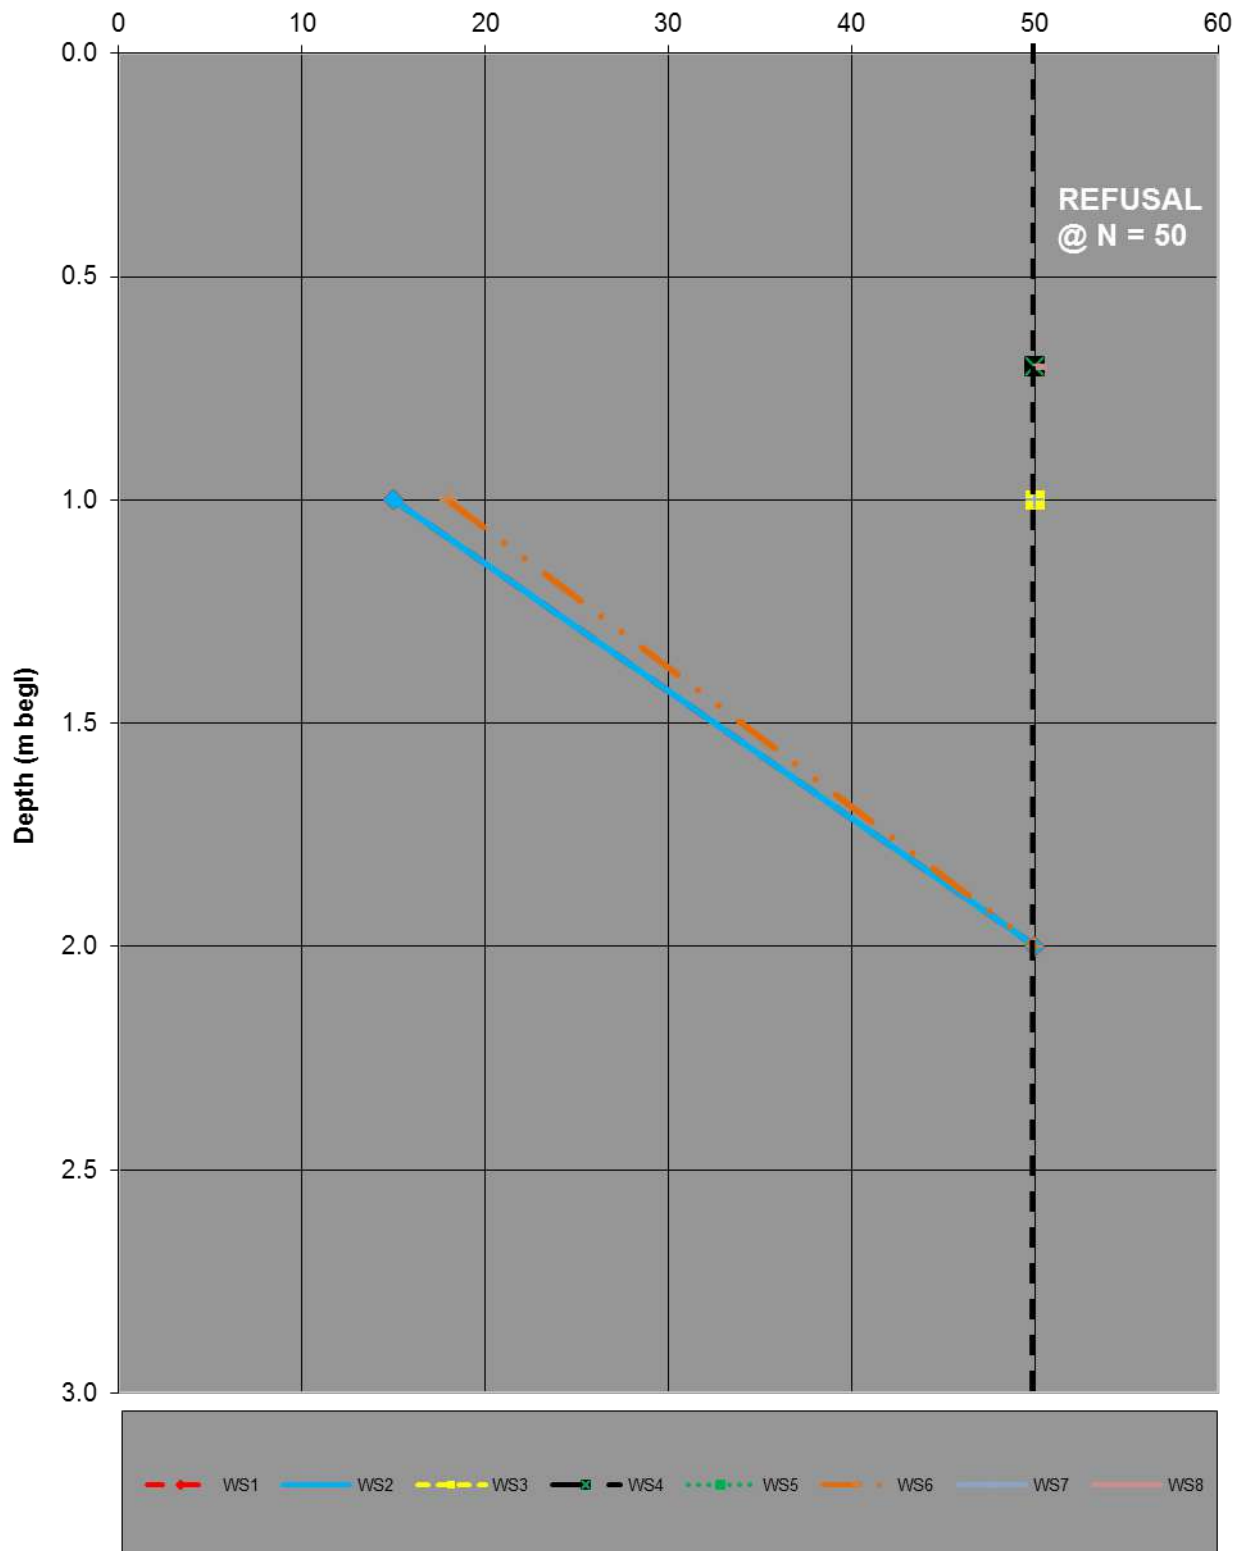
Chart 40056/02
Leconfield Road, Nanpantan
 SPT N Values Vs Depth (m begl)

SPT N (Uncorrected)

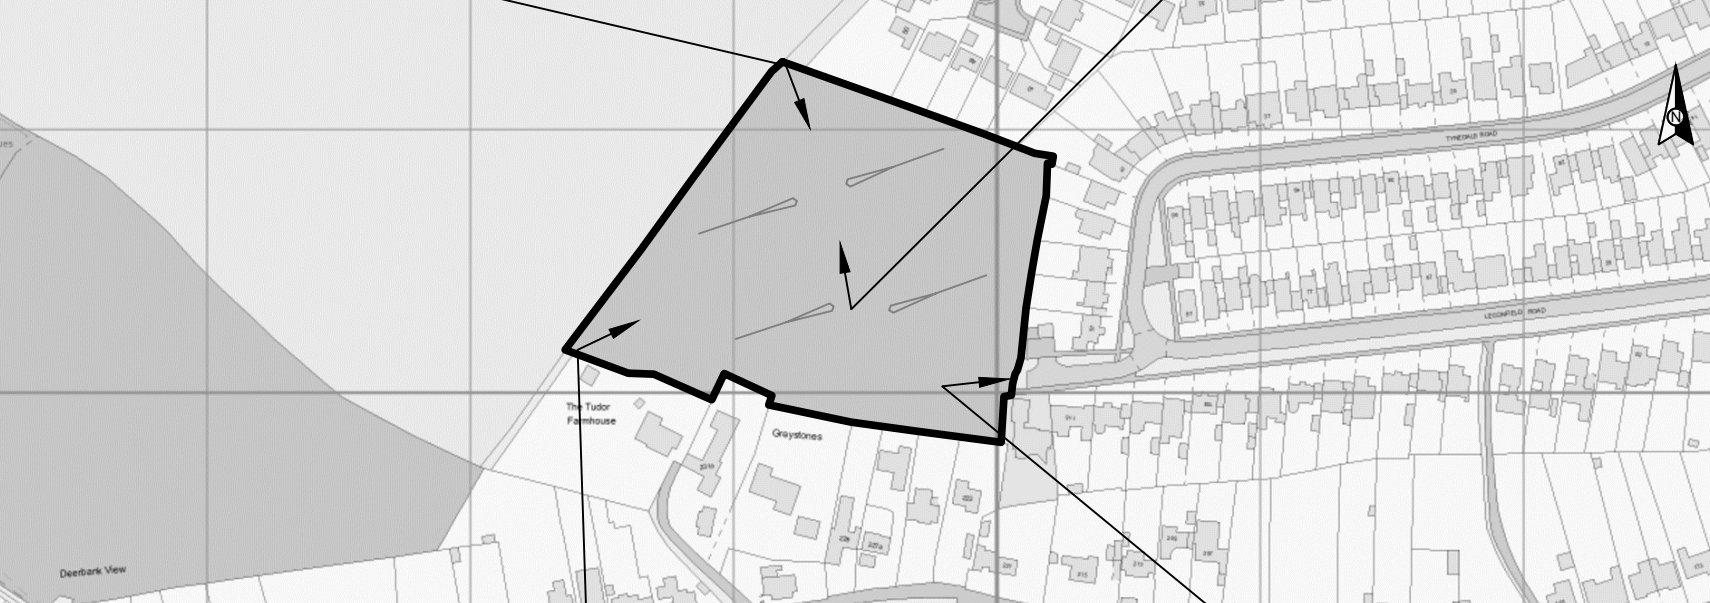
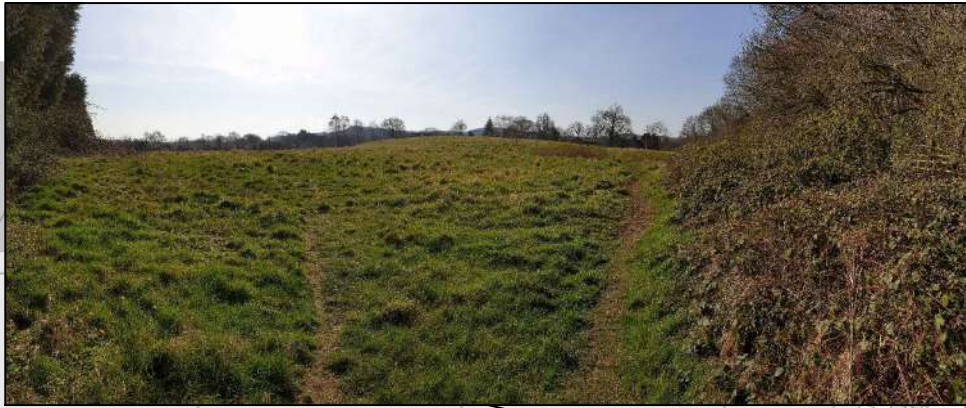
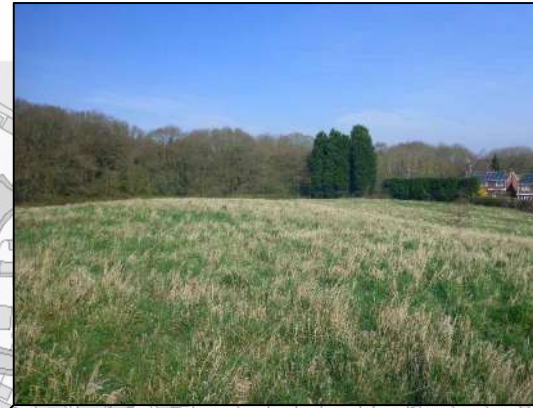
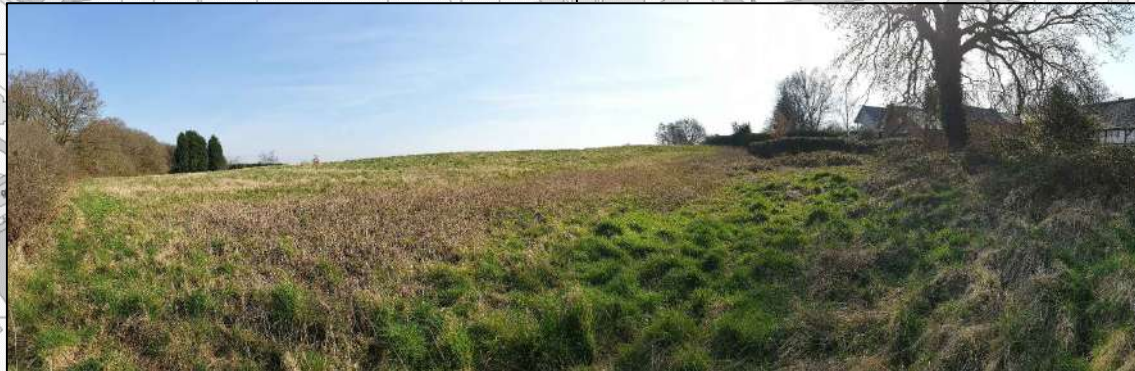
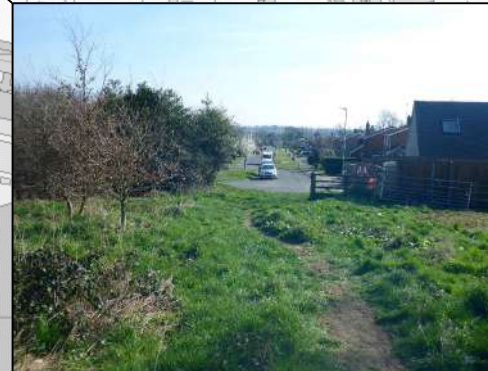
**Site Plan and General Views of Site
(Figure No. 40056-2/03 and 04)**

The site is generally covered with rough grasses with occasional semi-mature trees (potentially self set). Areas of rough vegetation were noted along part of the sites northeastern boundary.

The topographically lower areas of the site were noted to be wet underfoot. This was especially apparent towards the sites far western corner.

A number of tracks/footpaths were noted crossing the site, however, it is possible that these are informal as they are not indicated on 1:25000 Ordnance Survey mapping.

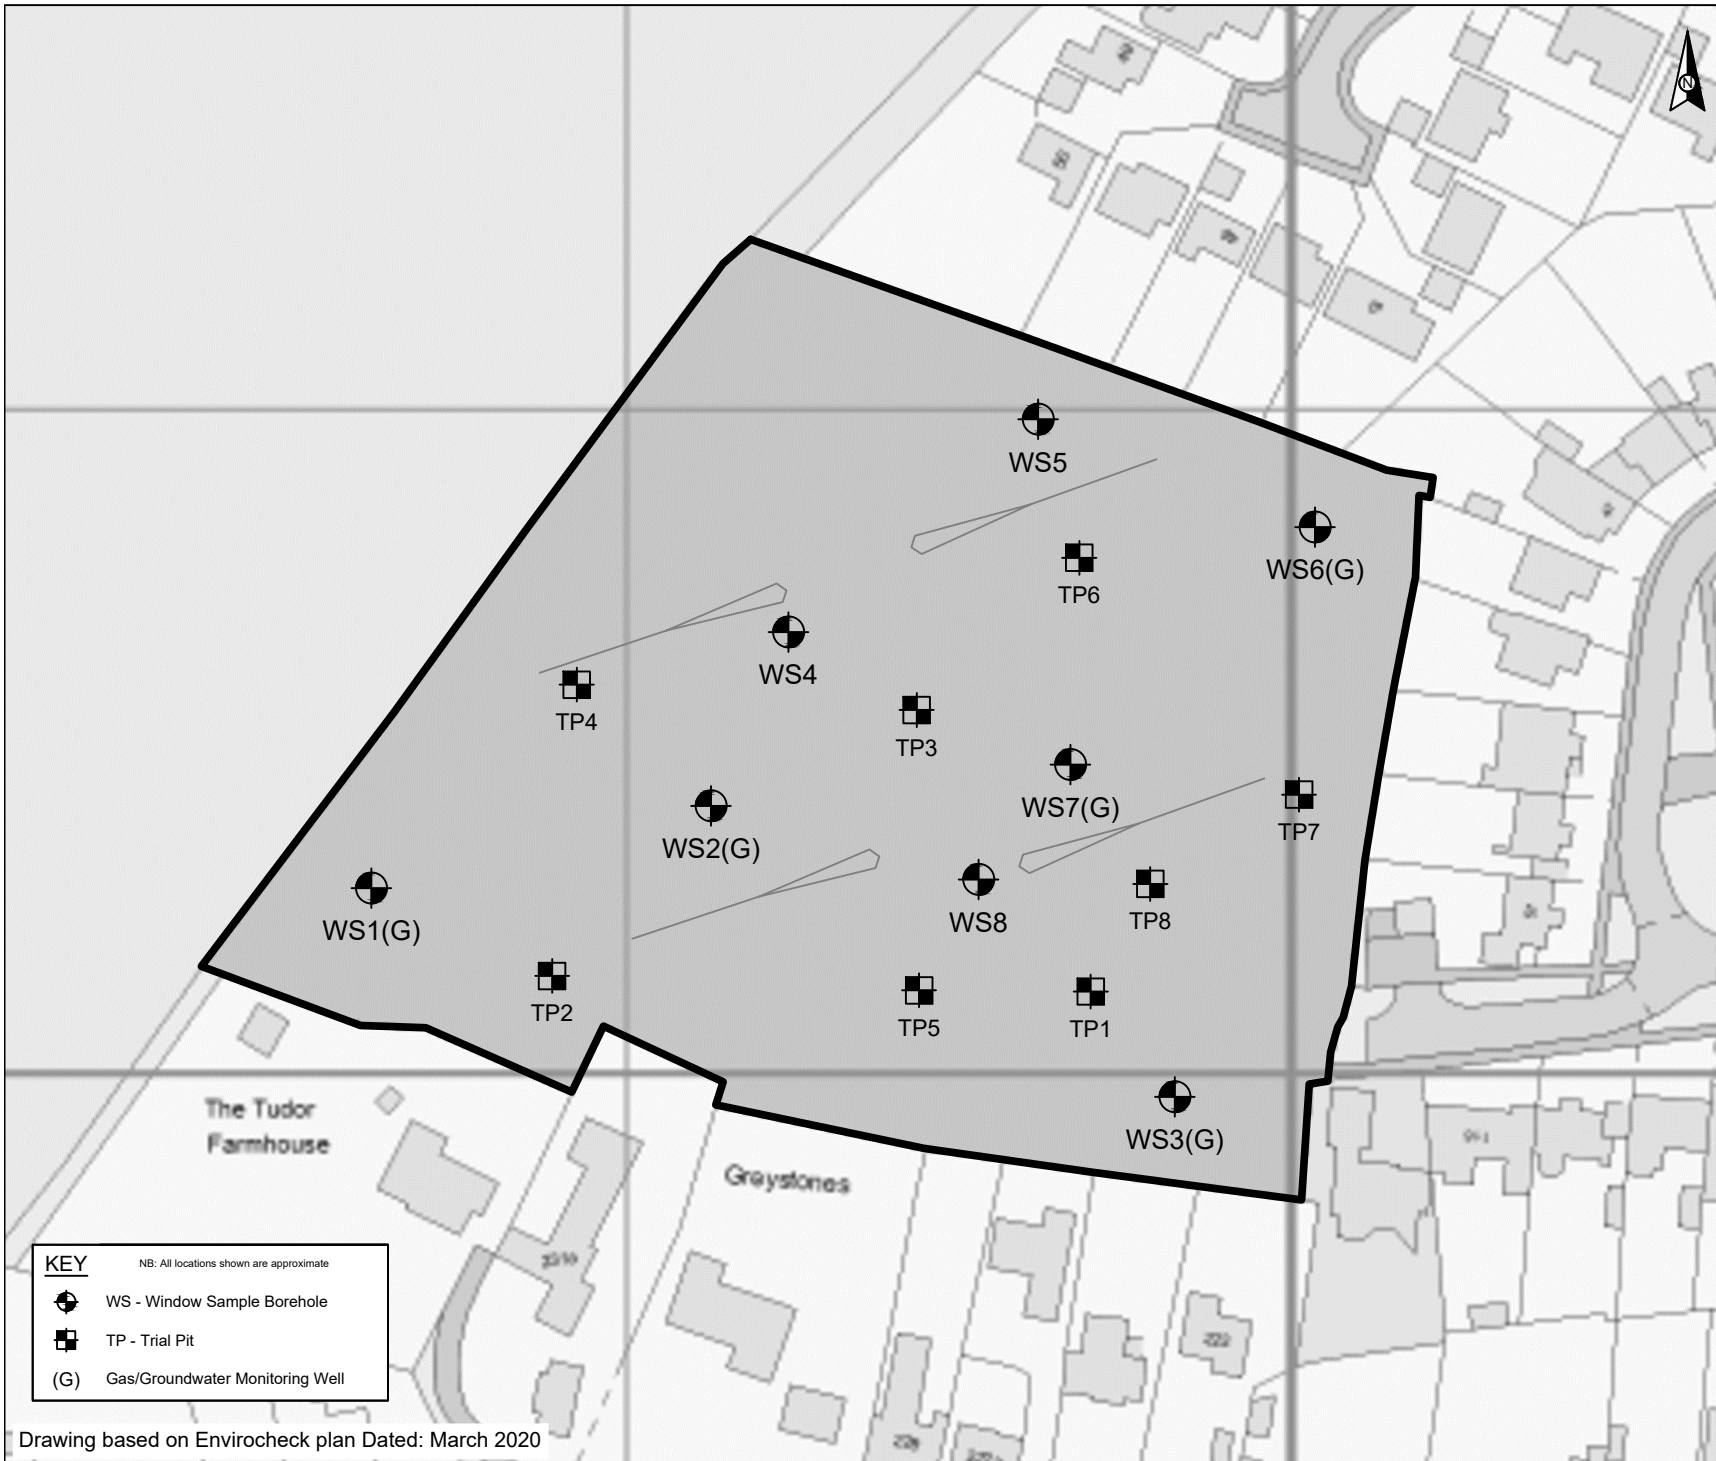
**Exploratory Hole Location Plan
(Figure No. 40056-2/05)**

A series of 8No. mechanically excavated trial pits (designated TP1 to TP8) were undertaken at the site to depths ranging between 1.80m and 2.90m begl on the 8th July 2020. Selected trial pits were observed by an earthwork's contractor at the request of Bowbridge Homes Ltd.

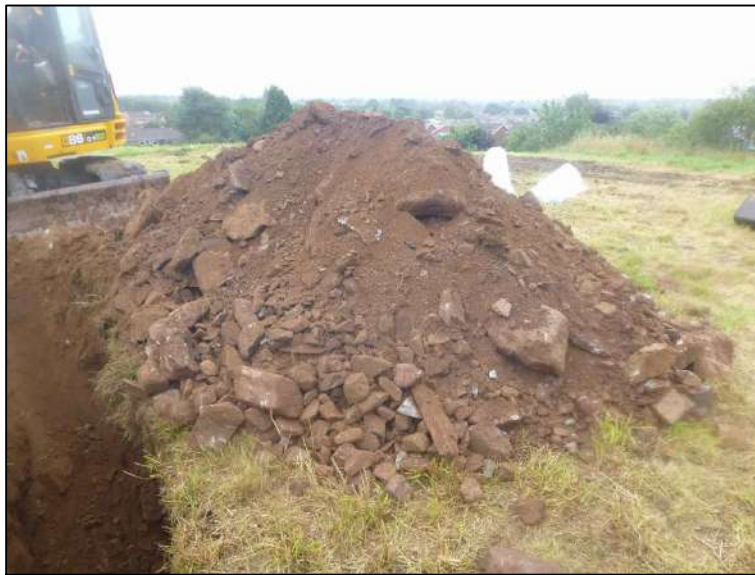
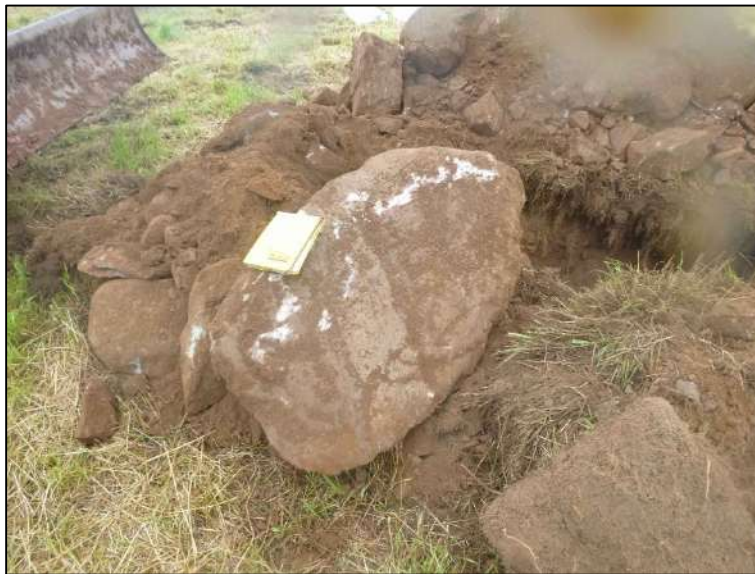
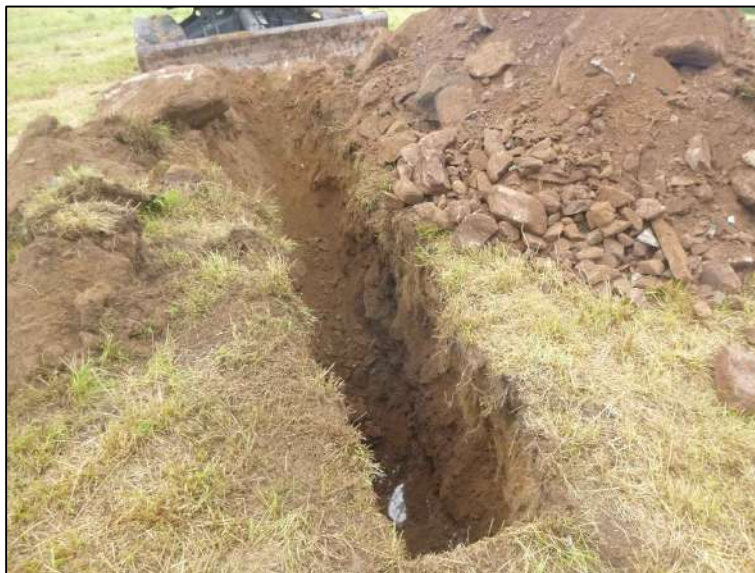
Project No.	40056-2	Drawn By	ACH
Client	Bowbridge Homes Ltd	Checked By	NC
		Approved By	JPH
Project	Leconfield Road, Nanpantan	Scale	NTS
		Date Drawn	28/07/2020
Title	Views of Exploratory Hole TP5 and Arisings	Revision	
		Figure No.	40056-2/P9

TABLE 5 – SUMMARY OF LABORATORY CBR TEST RESULTS				
Sample Ref.	Depth (m begl)	Initial Moisture Content (%)	CBR Value Sample Top (%)	CBR Value Sample Bottom (%)
TP5 (Meta-Mudstone)	0.50-1.00	10	50.7	38.8
TP6 (Sand)	0.60-0.80	14	28.6	20.7
TP7 (Clay)	1.00	19	11.1	11.0
