BS5837:2012 Tree Survey
 Land west of Leconfield Road
 Loughborough
 Leicestershire
 NGR SK50951 17549

SAFETY SCHEMES IN PROCUREMENT	Report prepared by: C Barker	Date Issued: 23 November 2020
		Report Version: Final
	Reviewed by: KLB	
	Report ref: P2164 /1020 /02	C B E Consulting Highbank, 5 Grantham Road, Navenby Lincoln. LN5 0JJ. Telephone (01522) 810086. www.cbeconsulting.co.uk

BS5837 Tree Survey, Land west of Leconfield Road

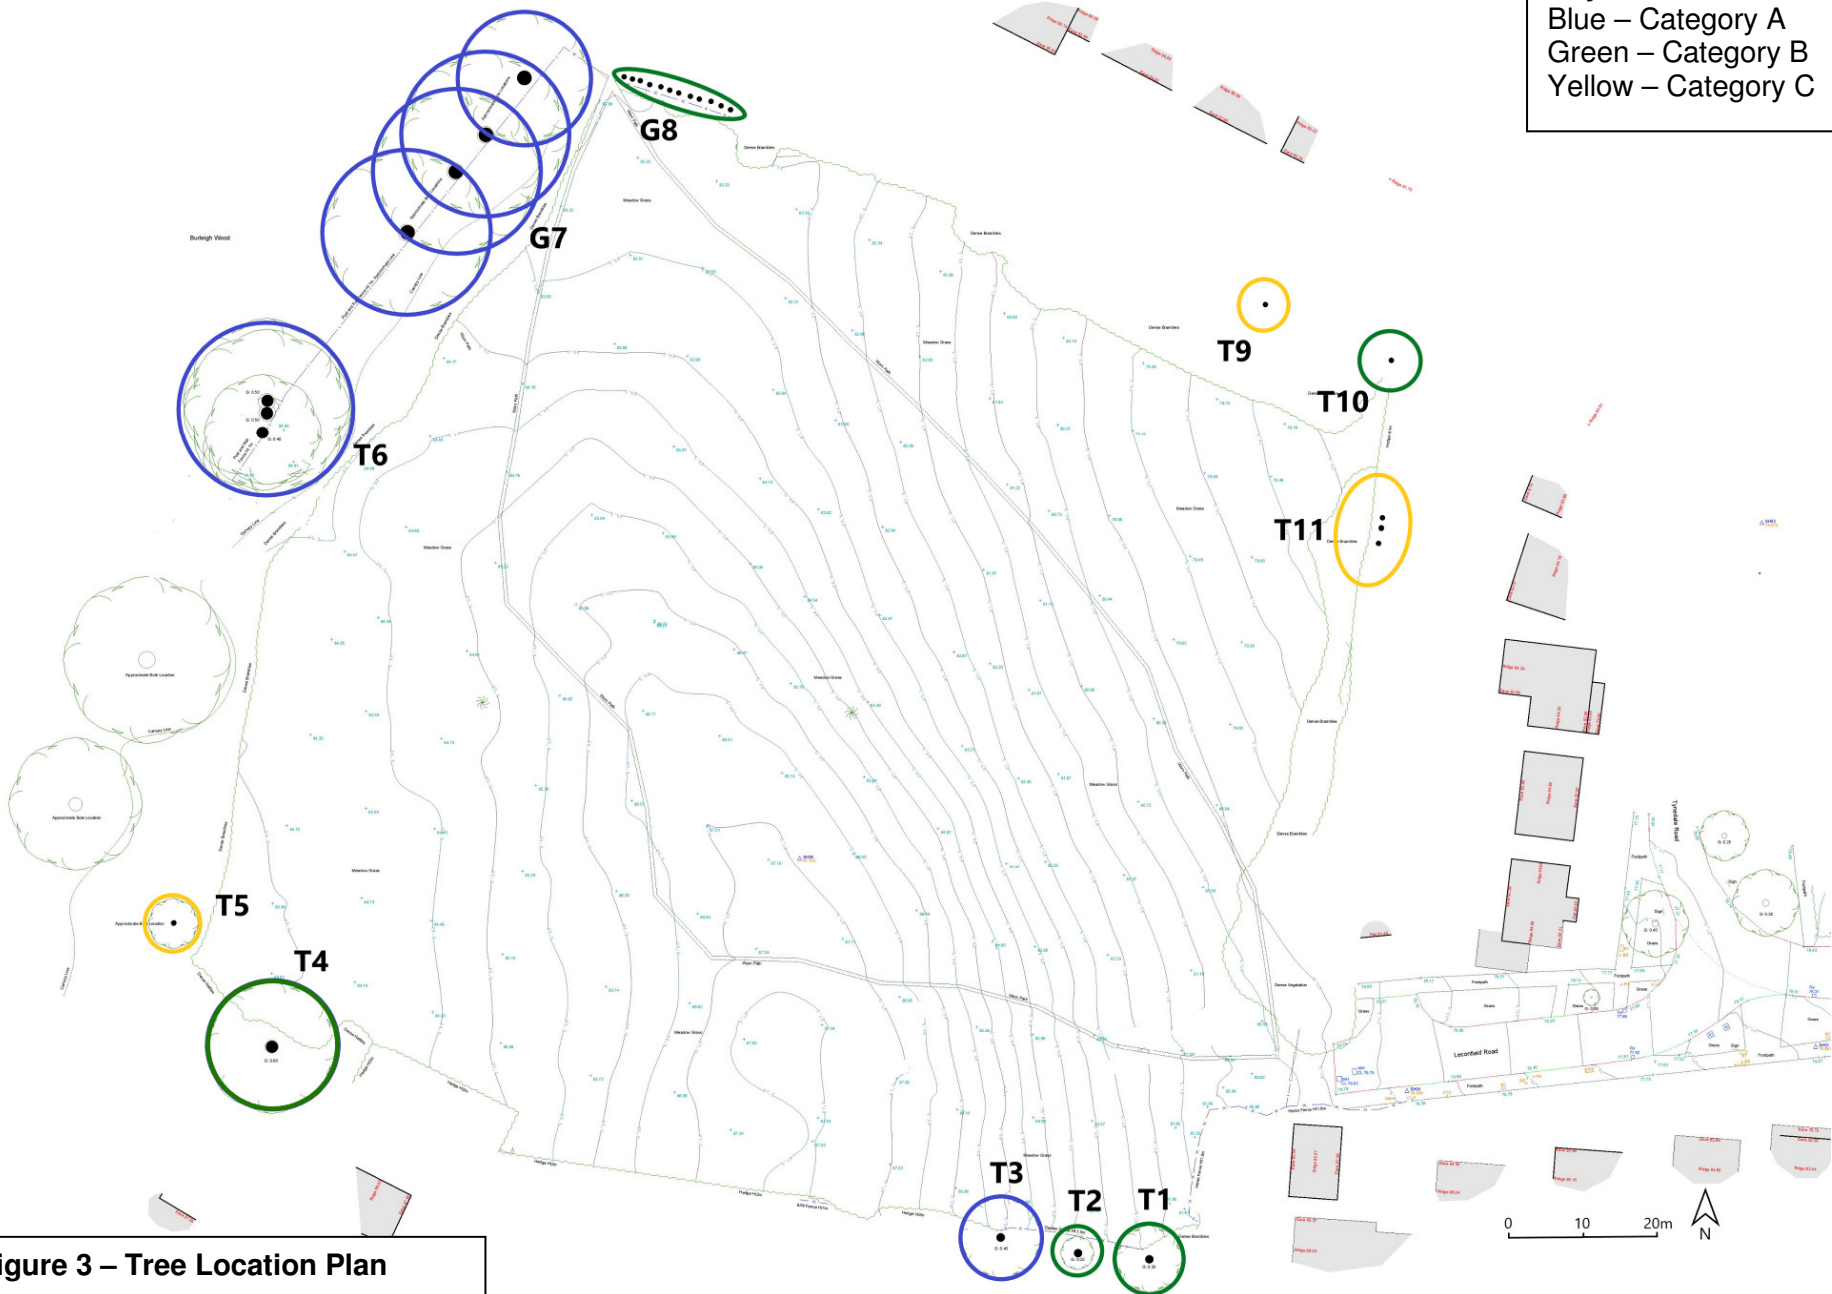
Figure 3 – Tree Location Plan

The position of significant individual trees or groups of trees on the site is shown on the Tree Location Plan **Figure 3**. Within the summary table (**Appendix 1**) a calculated corresponding radius of the circle for each RPA has been calculated. The Root Protection Areas are formulated to assist when designing layouts in relation to trees and the calculated RPA's in Appendix 1 should be used to inform the design layout of this site. A root Protection Area plan has been prepared as **Figure 4** and a Constraints Plan showing RPA's and protection areas has been prepared using the development plan as a base is provided as **Figure 5**.

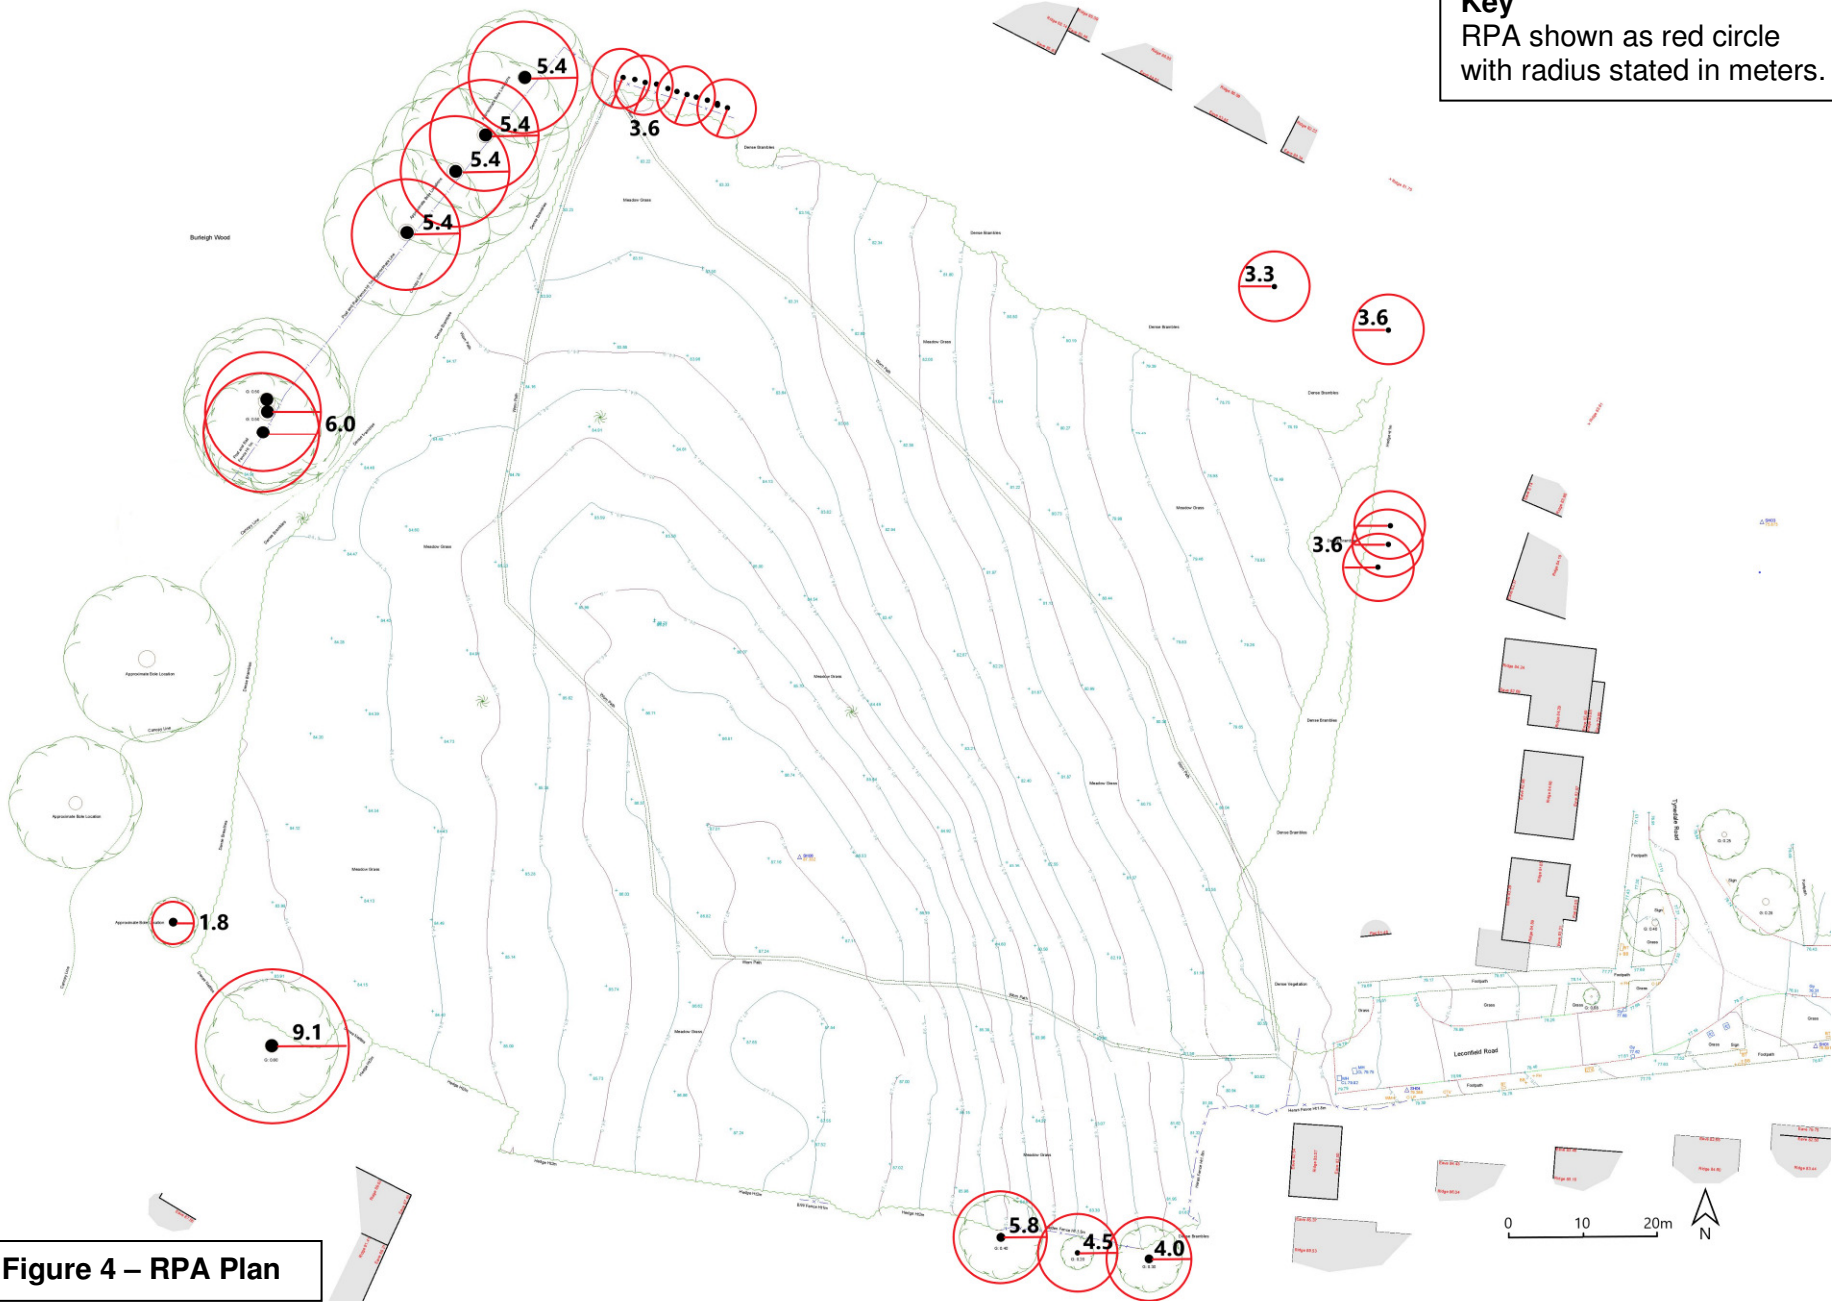
Figure 4 – RPA Plan

Key
RPA shown as red circle
with radius stated in meters.
